**LISTE DES ANNEXES**

**Accident  
survenu le 6 novembre 2002  
en approche de l'aéroport  
de Luxembourg  
au Fokker 50  
immatriculé LX-LGB  
exploité par Luxair**

*Accident  
occurred on November 6, 2002,  
on approach to  
Luxembourg Airport  
to the Fokker 50  
registered LX-LGB  
operated by Luxair*

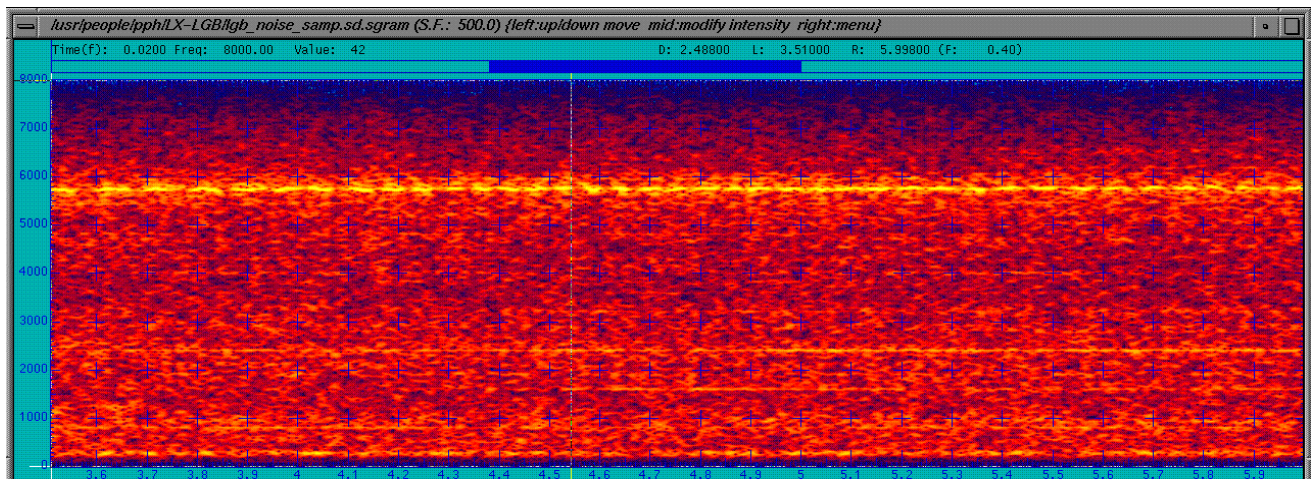
**Fig. 1: Représentation Temps – Fréquence du bruit de fond du LX-LGB en vol. Time – Frequency representation of the background noise on LX-LGB in flight.**

Comme l'illustrent les deux figures précédentes, le LX-LGB (fig. 1) présente un signal plus bruité que celui du LX-LGC (fig. 2). Les hautes fréquences (autour de 5700 Hz) correspondent au bruit de la turbine de l'avion. Le bruit de fond est globalement plus élevé en raison du bruit aérodynamique caractérisé par un spectre large bande.

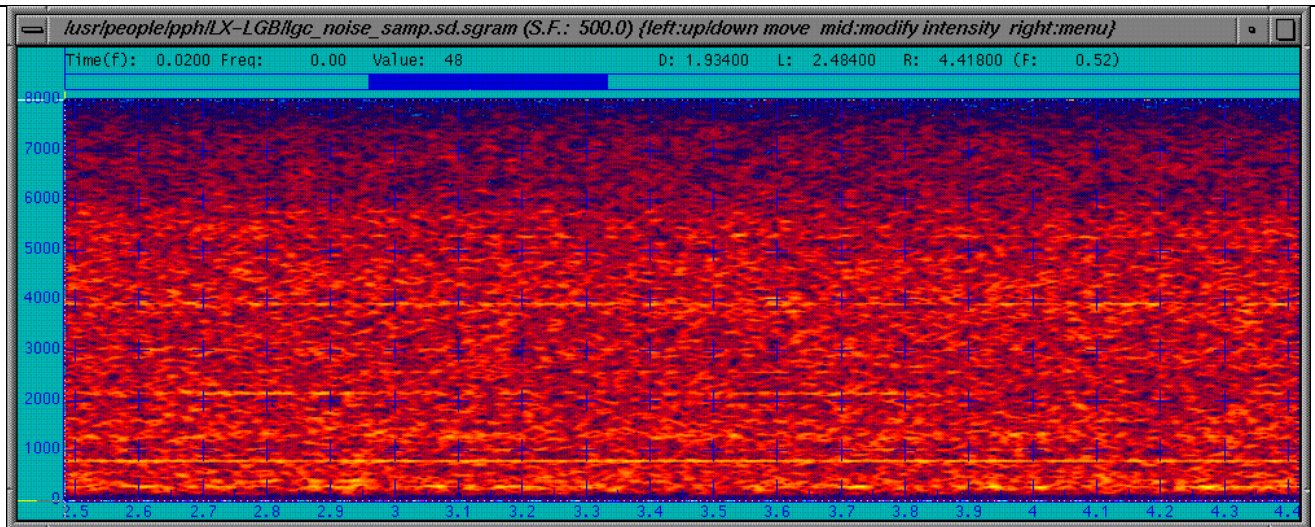
**Fig. 2: Représentation Temps – Fréquence du bruit de fond du LX-LGC au sol. Time – Frequency representation of the background noise on LX-LGC on the ground.**

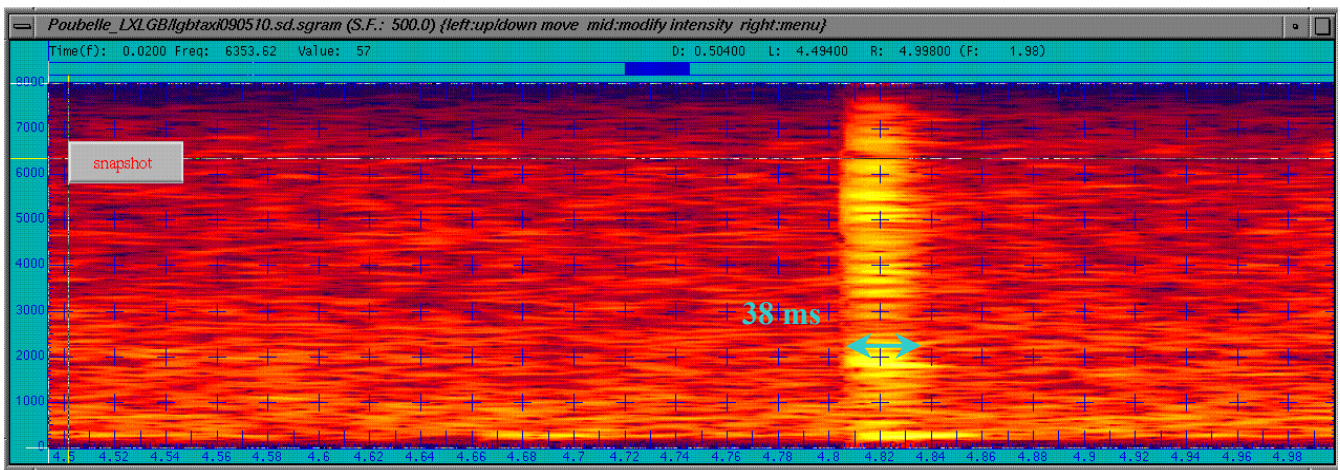
**Fig. 3:** Représentation Temps – Fréquence du bruit transcrit. *Time – Frequency representation of the transcribed noise.*

La figure ci-dessus représente le bruit enregistré sur le CVR de l'accident et transcrit comme l'activation des taxi lights. La figure suivante représente un enregistrement du bruit généré par l'activation des taxi lights lors des essais au sol.

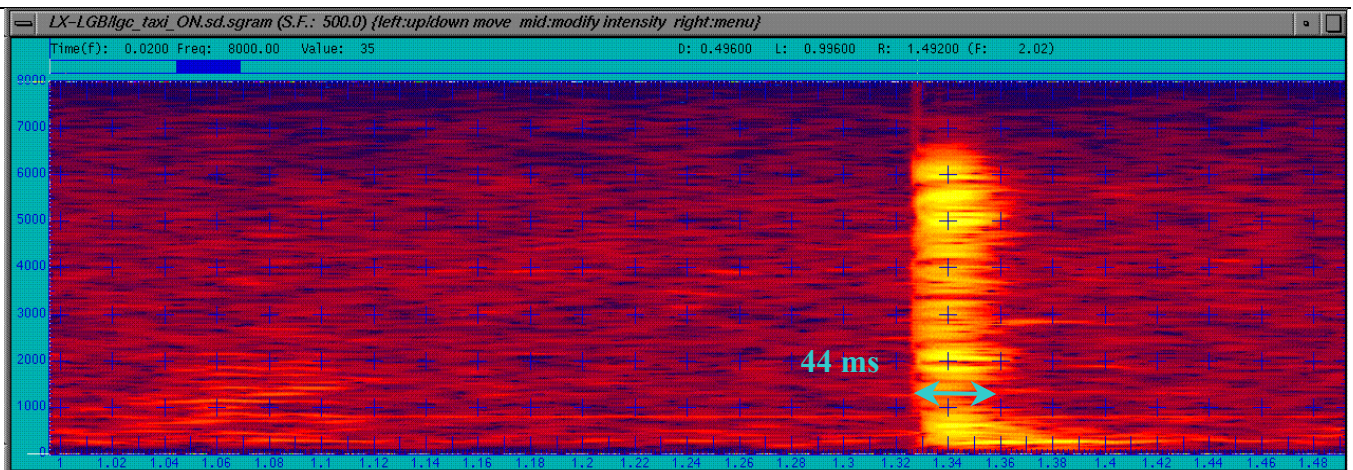
**Fig. 4:** Représentation Temps-Fréquence du bruit généré. **Time – Frequency representation of the generated noise.**

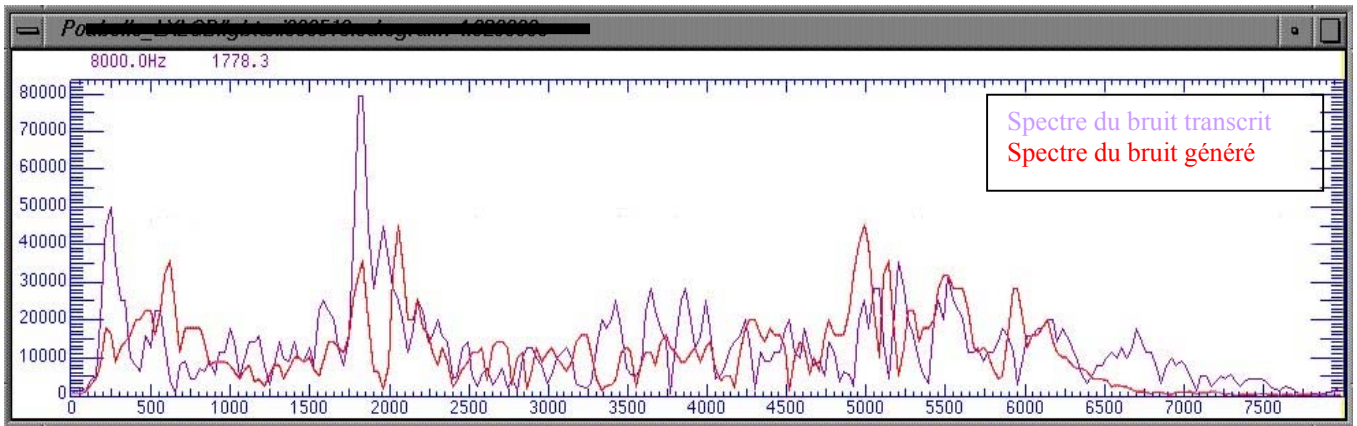
**Fig. 5: Comparaison des composantes fréquentielles des bruits transcrit (en mauve) et généré (en rouge). Spectrum comparison between the transcribed noise (in mauve) and the generated noise (in red)**

On retrouve les mêmes composantes fréquentielles, notamment aux basses fréquences et autour de **2000** et **5000** Hz.

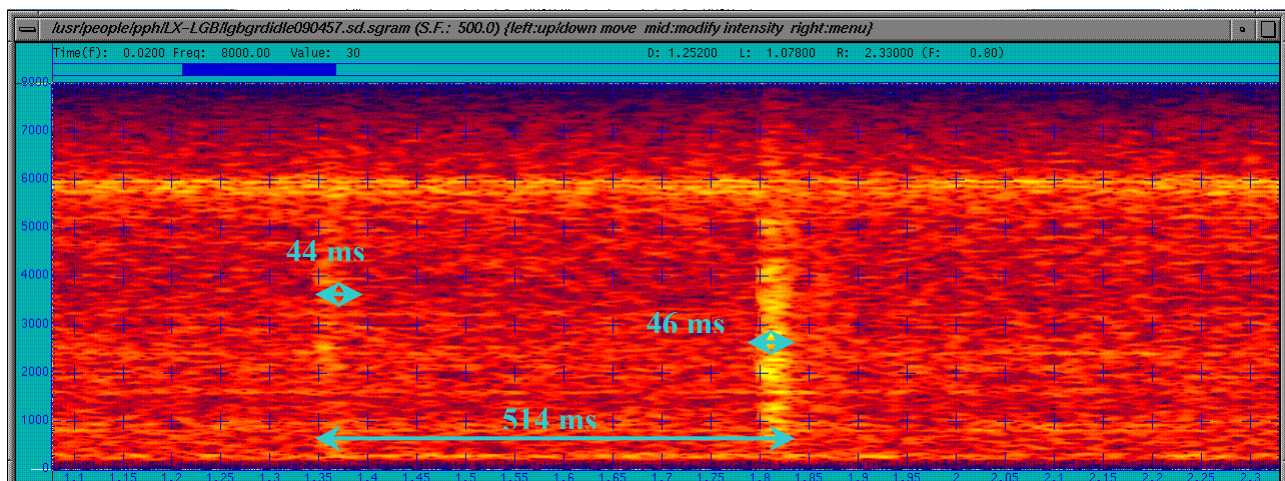
**09 h 04 min 58 s : "Bruit de sélecteur similaire au déplacement du Ground Idle Stop" / "Sound similar to the operation of the Ground Idle Stop Selector"**

**Fig. 6: Représentation Temps – Fréquence du bruit transcrit. Time – Frequency representation of the transcribed noise.**

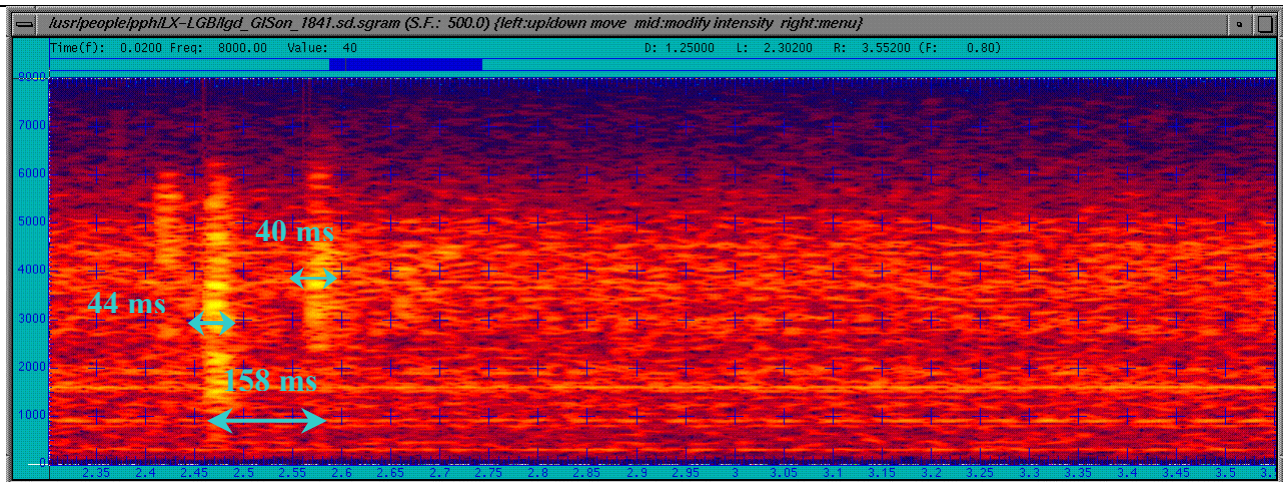
**Fig. 7: Représentation Temps-Fréquence du bruit généré. Time – Frequency representation of the generated noise.**

La figure précédente représente le bruit du déplacement du *Ground Idle Stop* vers la position OFF, dans le domaine temps- fréquence.

Dans le cas présent, les deux bruits ont une forme similaire et peuvent se décomposer en 2 parties. **Cette forme est a priori cohérente avec l'hypothèse de la manœuvre du sélecteur en question** (le *Ground Idle Stop*). En effet, manipuler ce sélecteur suppose sa levée d'une butée, sa translation puis son ré-enclenchement dans sa nouvelle position, d'où le double bruit. Cette cinématique est la seule à produire ce double bruit, à l'exception de la manœuvre des commandes de gaz, des volets et du train d'atterrissage. Ces deux dernières commandes cependant ont une signature spectrale bien différente que l'on ne peut confondre avec le bruit analysé ici.

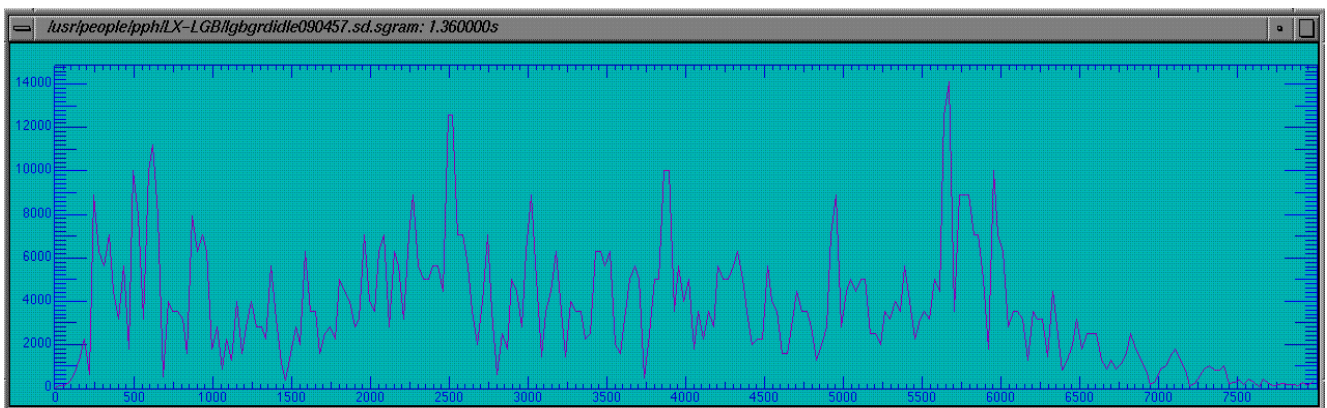
**Fig. 8: Représentation Fréquentielle du bruit à identifier. Frequency representation of the noise to be identified.**

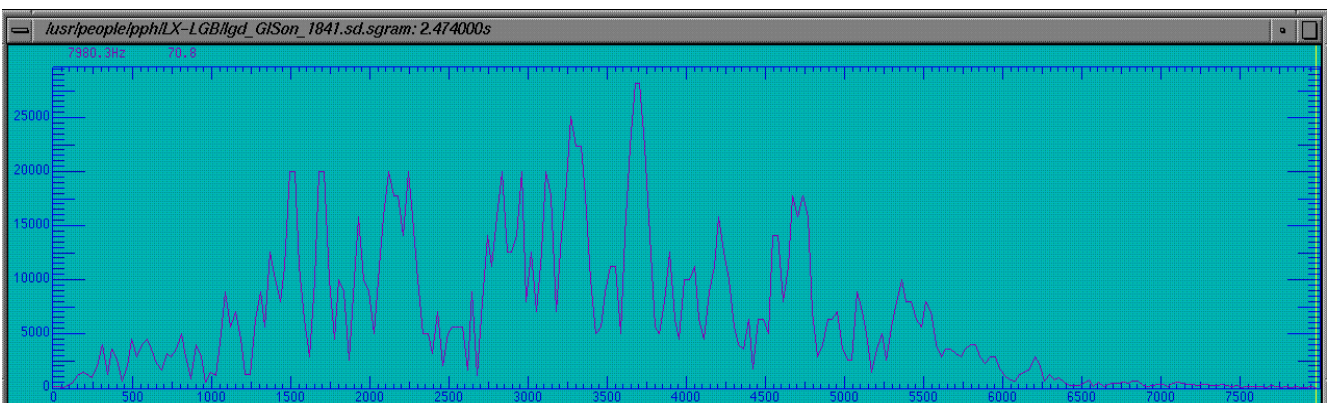
**Fig. 9: Représentation Fréquentielle du bruit généré. Frequency representation of the generated noise.**

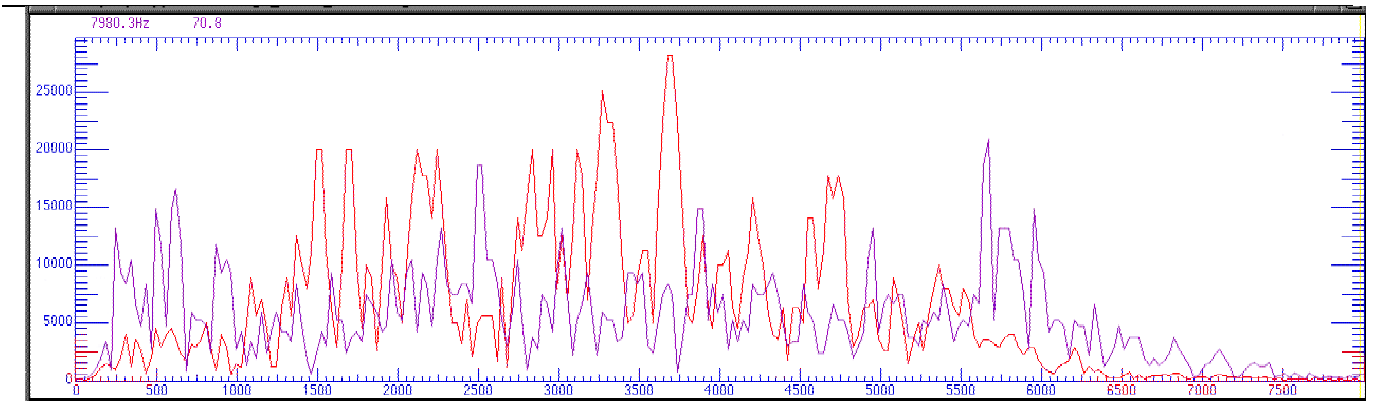
**Fig. 9bis : Comparaison des composantes fréquentielles des bruits transcrit (en mauve) et généré (en rouge). Spectrum comparison between the transcribed noise (in mauve) and the generated noise (in red)**

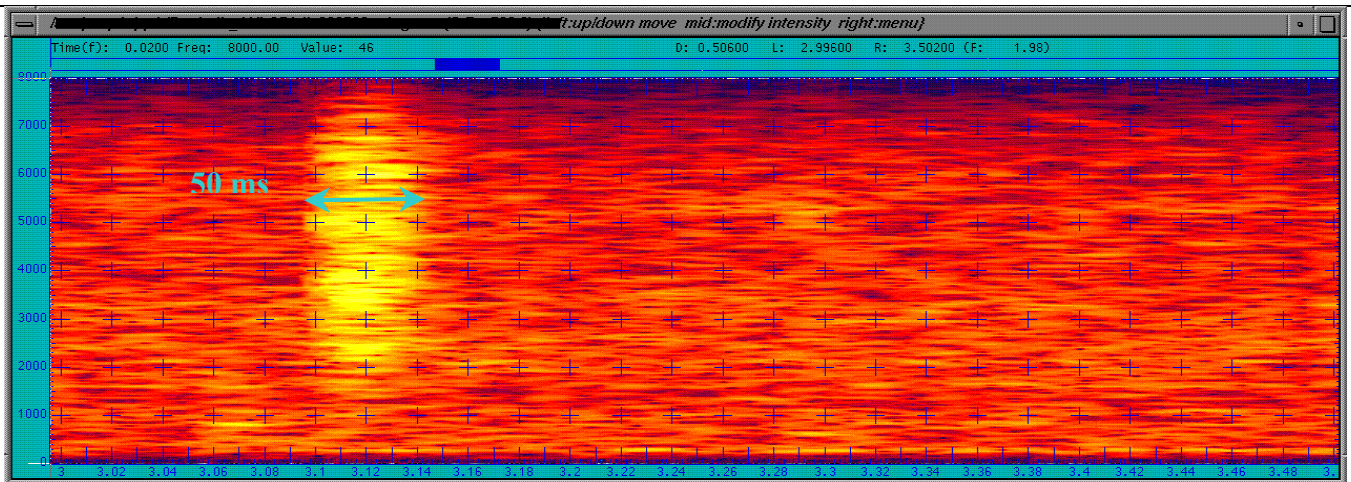
**Fig. 10: Représentation Temps – Fréquence du bruit transcrit. Time – Frequency representation of the transcribed noise.**

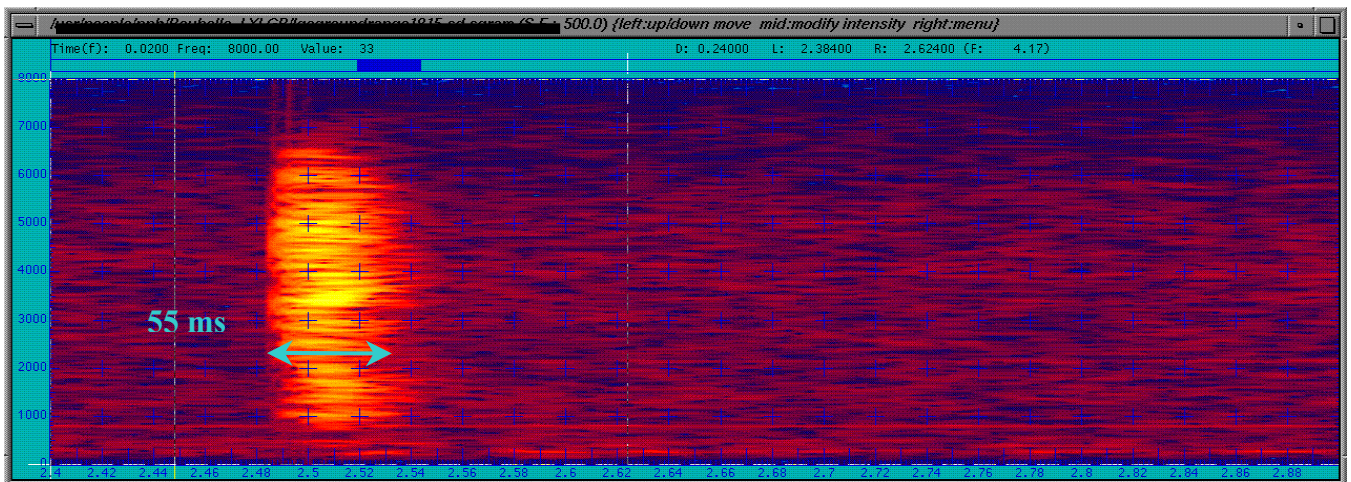
**Fig. 11: Représentation Temps-Fréquence du bruit généré. Time – Frequency representation of the generated noise.**

La figure ci-dessus représente le bruit du déplacement des *Ground Range Selector* dans le domaine temps - fréquence dans le cas où les deux leviers sont soulevés simultanément afin de retrouver une forme semblable à celle obtenue avec le bruit transcrit.

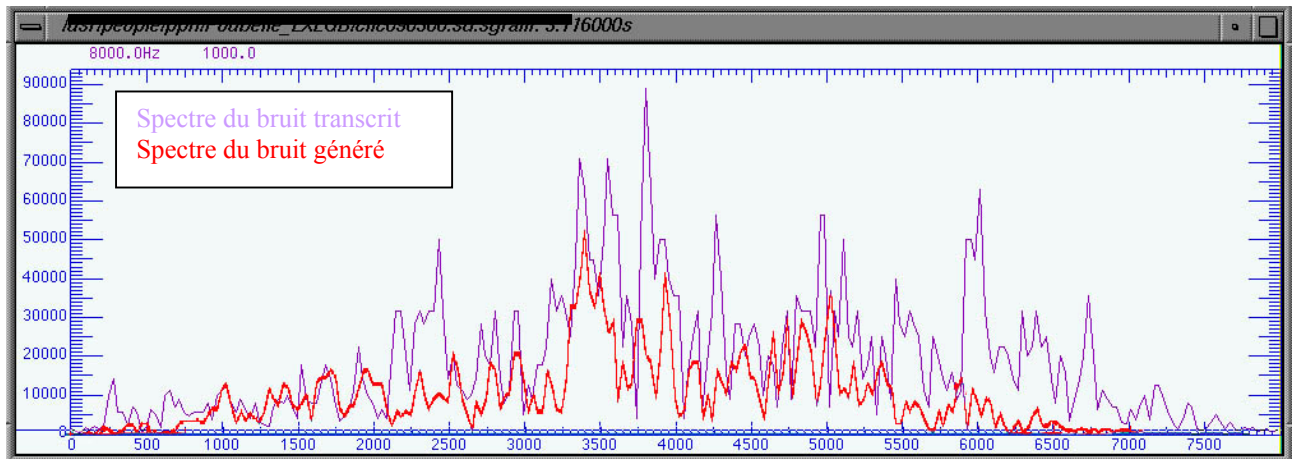
**Fig. 12: Comparaison des composantes fréquentielles des bruits transcrit (en mauve) et generé (en rouge). Spectrum comparison between the transcribed noise (in mauve) and the generated noise (in red)**

La figure ci-dessus est une superposition des représentations fréquentielles du bruit transcrit et du bruit généré. Les intensités du spectre du bruit transcrit apparaissent logiquement supérieures à celles du bruit généré (voir paragraphe 3.2 *Environnement sonore / Acoustic environment*). On constate ainsi que les deux spectres sont très proches. On rappelle que les pics entre 5500 et 6000 Hz proviennent du fonctionnement du turbopropulseur.

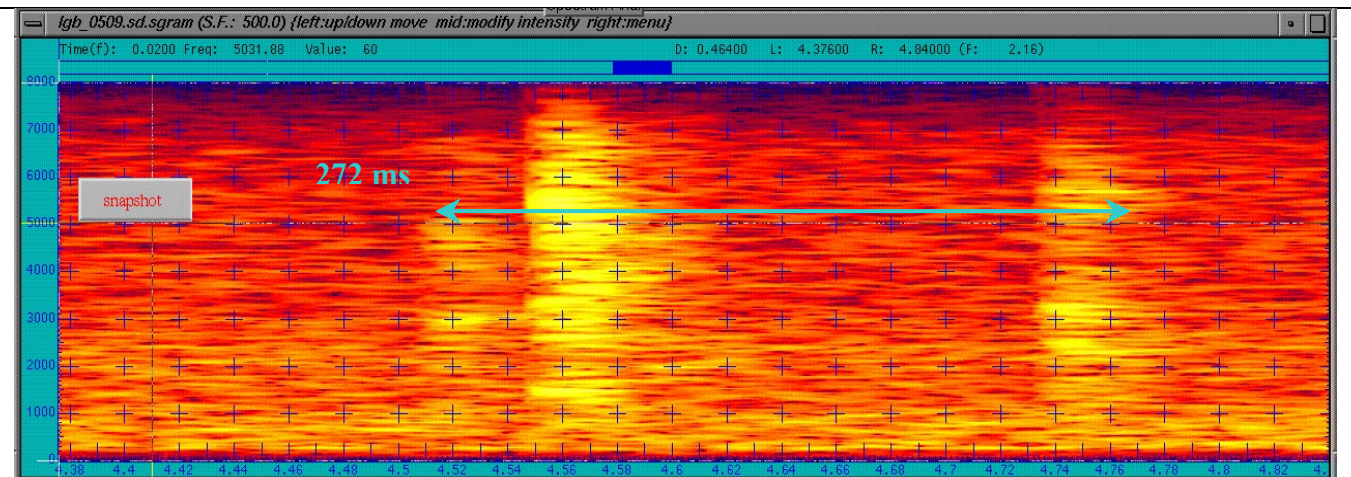
**Fig. 13: Représentation Temps – Fréquence du bruit transcrit. Time – Frequency representation of the transcribed noise.**

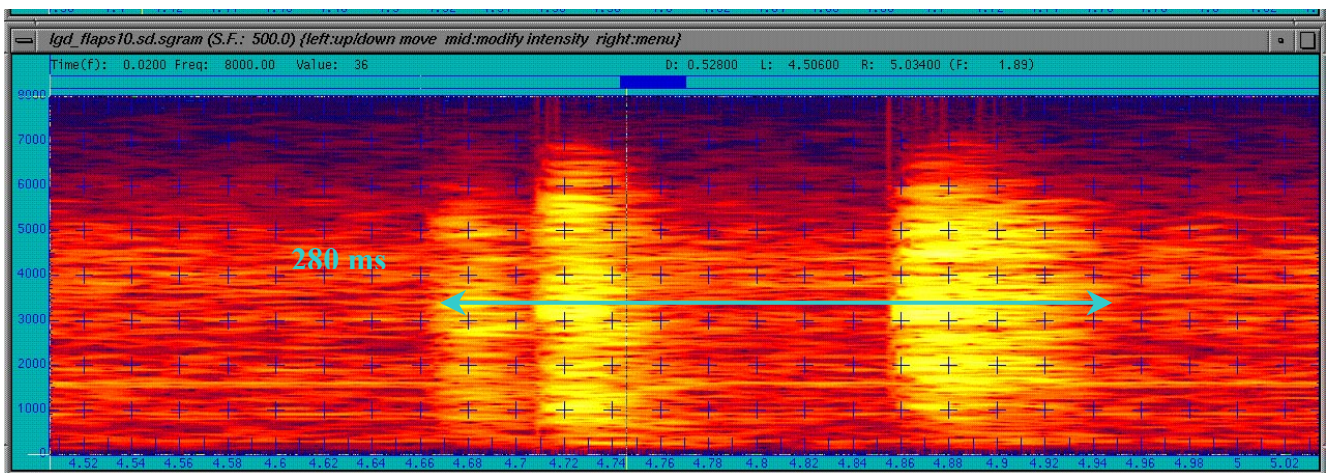
**Fig. 14: Représentation Temps-Fréquence du bruit généré. Time – Frequency representation of the generated noise.**

*The preceding figures illustrate the similarities between the two noises, where the same signature shape and rates are found.*

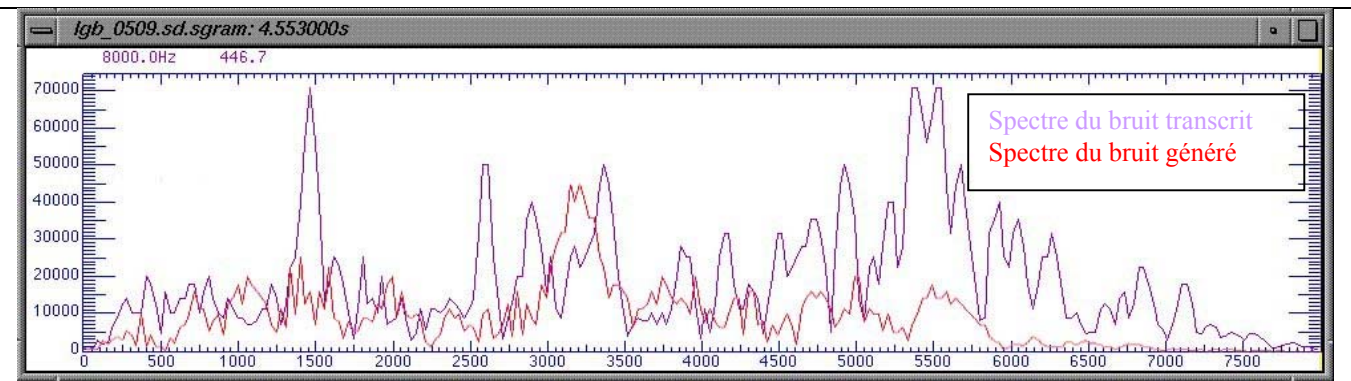
**Fig. 15:** Comparaison des composantes fréquentielles des bruits transcrit (en mauve) et généré (en rouge). **Spectrum comparison between the transcribed noise (in mauve) and the generated noise (in red)**

Bien que moins évidents, les résultats de la figure ci-dessus permettent de retrouver les points communs entre les deux bruits, notamment autour de **3250, 3800, 5000 et 5500 Hz**.

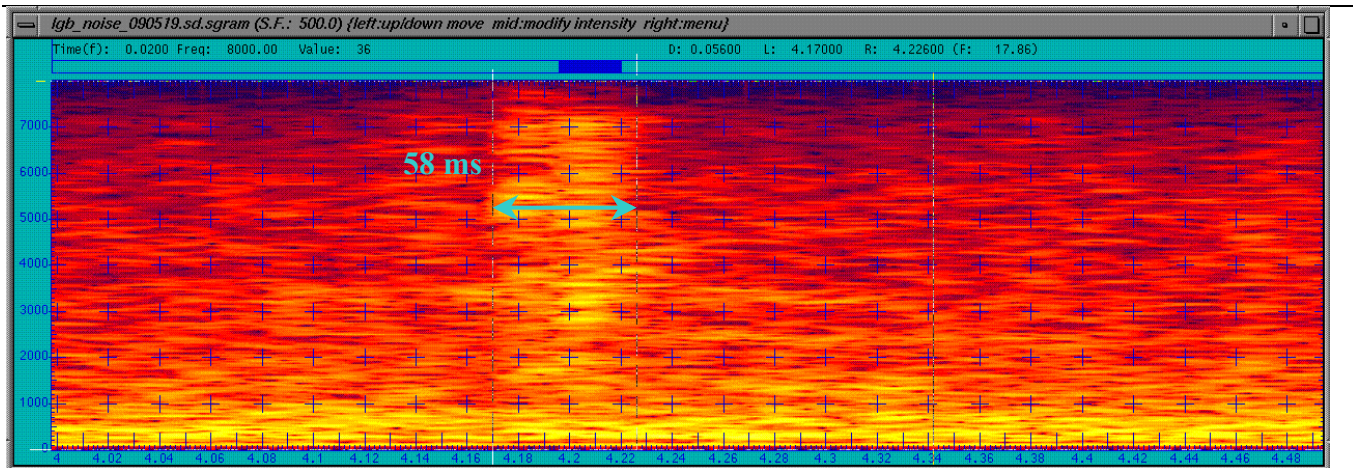
**09 h 05 min 19 s : "Bruit" / "Noise"**

**Fig. 16:** *Représentation Temps - Fréquence du bruit à identifier). Time Frequency representation of the noise to be identified.*

Ce bruit peut se décomposer temporellement en deux parties correspondant à deux « clics » distincts mais très rapprochés. Sa durée totale est de **58 ms**.

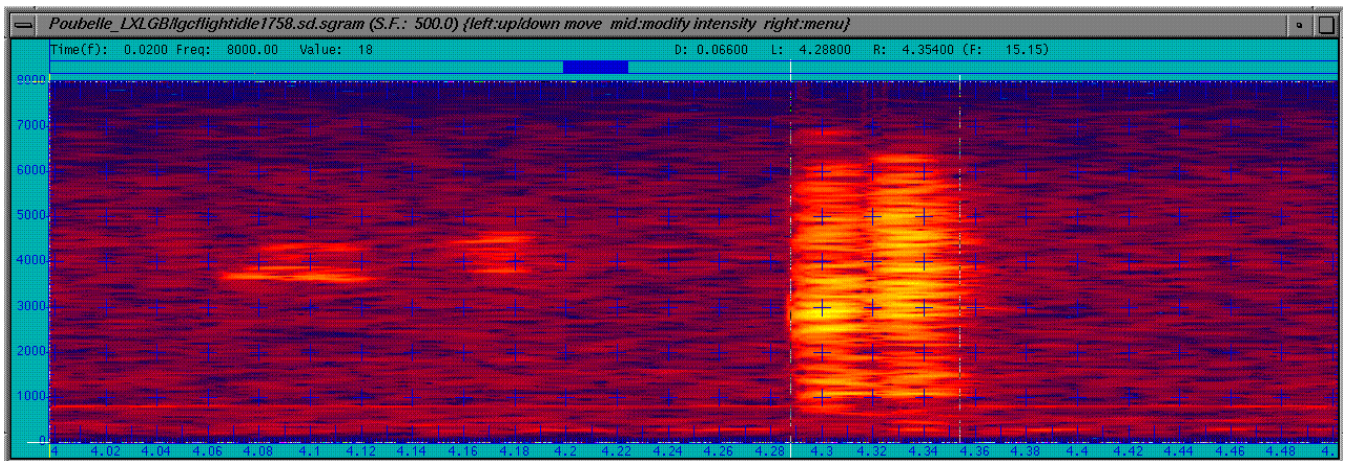
**Fig. 17:** *Représentation Temps - Fréquence du mouvement de la manette des gaz mise en position « Flight Idle ». Time Frequency representation of the operation of the throttle moved to « Flight Idle » position.*

La figure ci-dessus correspond à la manipulation des manettes des gaz sur le Fokker 50 immatriculé LX-LGC. Ces manettes étant en position *Ground Idle*, elles sont ramenées en position *Flight Idle*. On retrouve ici cette décomposition en deux clics distincts. La durée totale de ce bruit est de **70 ms**.

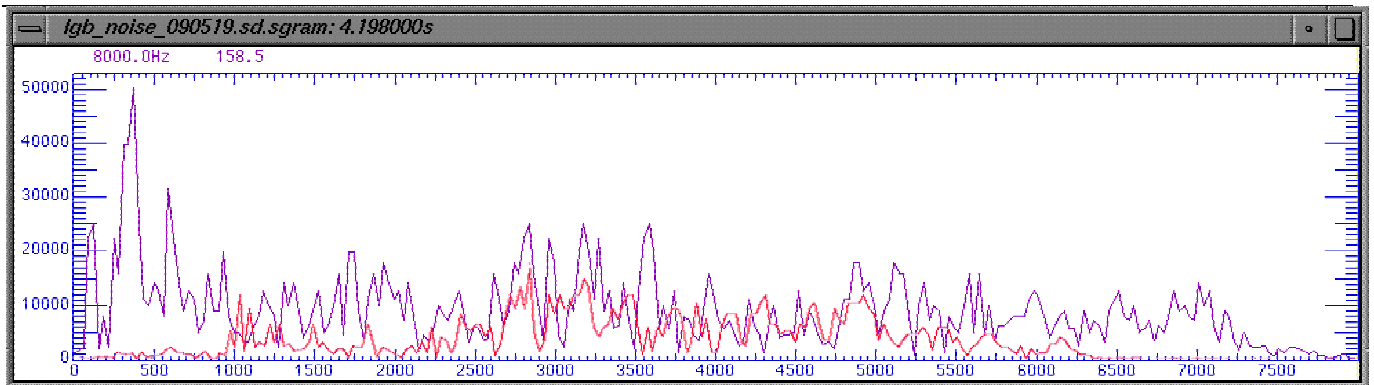
**Fig. 18:** Comparaison des composantes fréquentielles des bruits transcrit (en mauve) et généré (en rouge).  
**Spectrum comparison between the transcribed noise (in mauve) and the generated noise (in red)**

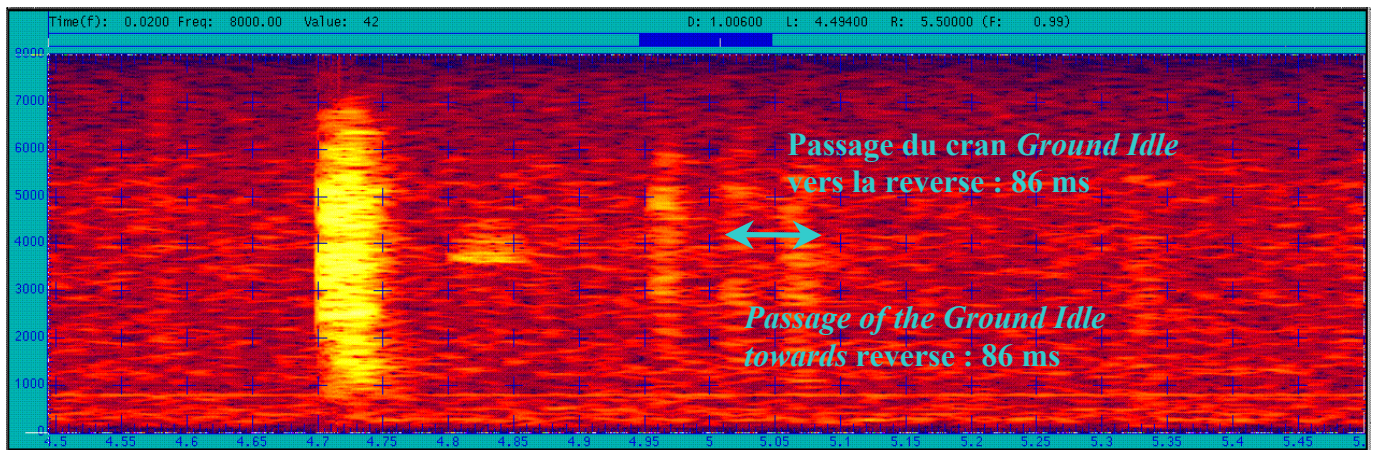
**Fig. 19:** Représentation Temps - Fréquence issue du mouvement de la manette des gaz mise en position « Reverse » depuis la position *Flight Idle*. **Time Frequency representation of the movement of the throttle from the Flight Idle position to the « Reverse » position.**

S'agissant d'un mouvement de manette, on retrouve encore la même décomposition du bruit. Dans le cas présent, ce bruit est plus long que celui transcrit, avec les causes connues décrites au paragraphe 3.4.2. Les comparaisons des spectres donnent :

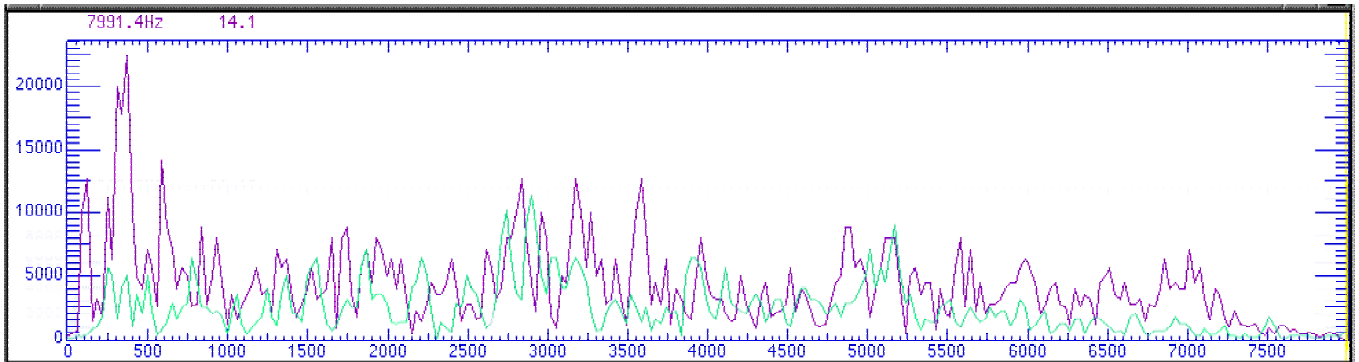
**Fig. 20:** Comparaison des composantes fréquentielles des bruits transcrit (en mauve) et generé (en vert). **Spectrum comparison between the transcribed (in mauve) and the generated noise (in green)**

*Here again, both spectra show similarities around 700, 1500, 3200, 4000 Hz... This is why the two previous noises tested were compared with each other in order to obtain a differential identification. The results in the figure below were thus obtained.*

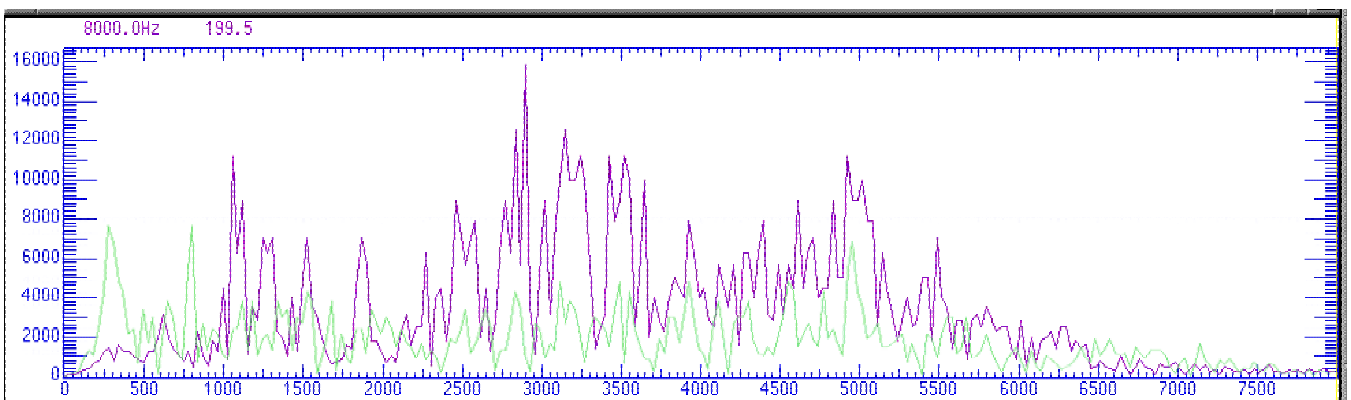
**Fig. 21:** Comparaison des composantes fréquentielles entre les manettes poussées en position Flight Idle (en mauve) et en reverse (en vert). **Spectrum comparison between the throttle set to Flight Idle position (in mauve) and Reverse position (in green)**

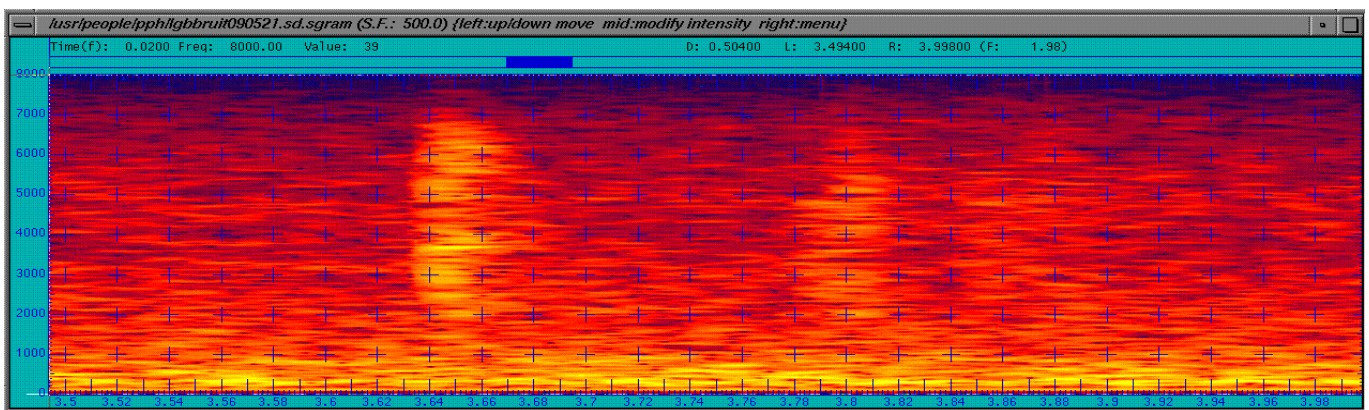
**09 h 05 min 21 s : "Bruit similaire à la manoeuvre de la commande des flaps" / "Sound similar to the operation of flaps control"**

**Fig. 22 : Représentation Temps – Fréquence du bruit. Time – Frequency representation of the noise.**

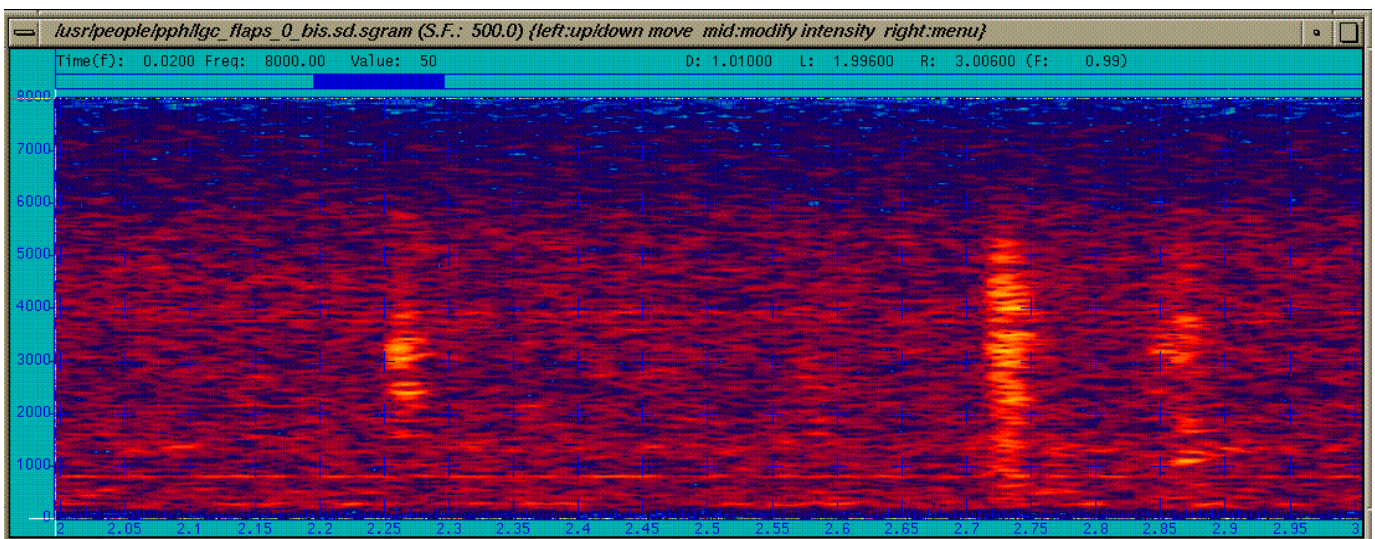
**Fig. 23 : Représentation Temps – Fréquence du bruit de la commande des volets ramenée en position 0°. Time – Frequency representation of the flaps command noise moved to 0°.**

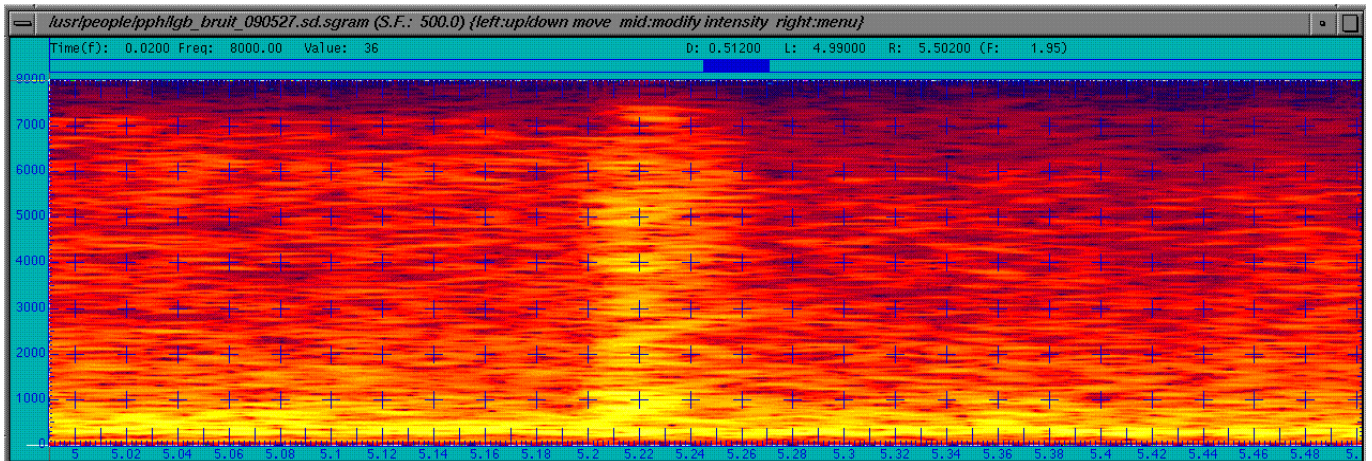
**09 h 05 min 27 s : "Bruit" / "Noise"**

**Fig. 23 :** Représentation Temps – Fréquence du bruit. *Time – Frequency representation of the noise.*

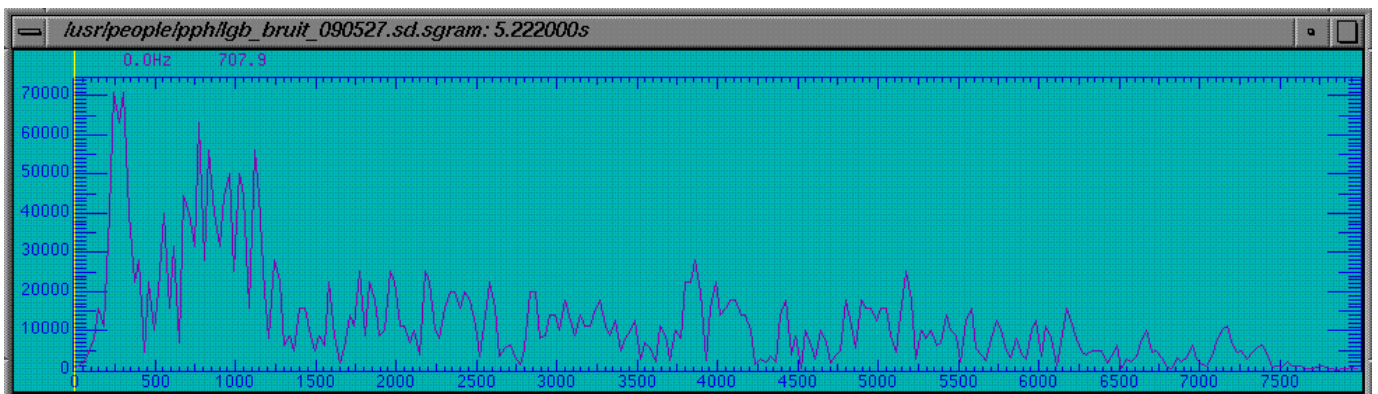
**Fig. 24 :** Spectre du bruit inconnu. *Spectrum of the unidentified noise.*
