**Accident  
survenu le 6 novembre 2002  
en approche de l'aéroport  
de Luxembourg  
au Fokker 50  
immatriculé LX-LGB  
exploité par Luxair**

*Accident  
occurred on November 6, 2002,  
on approach to  
Luxembourg Airport  
to the Fokker 50  
registered LX-LGB  
operated by Luxair*

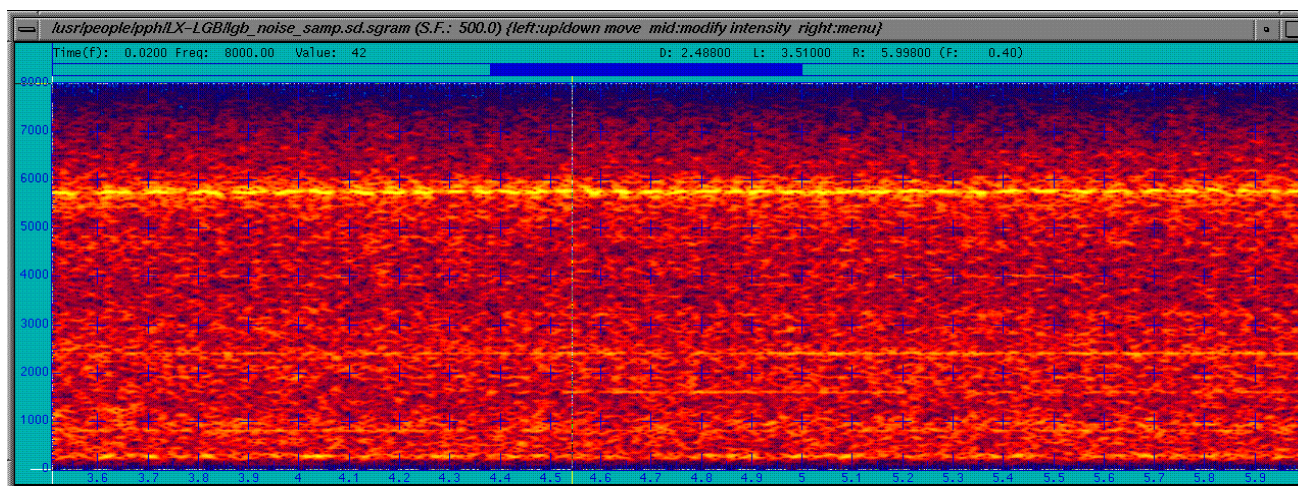
**Fig. 1: Représentation Temps – Fréquence du bruit de fond du LX-LGB en vol. Time – Frequency representation of the background noise on LX-LGB in flight.**

**Fig. 2: Représentation Temps – Fréquence du bruit de fond du LX-LGC au sol. Time – Frequency representation of the background noise on LX-LGC on the ground.**

Comme l'illustrent les deux figures précédentes, le LX-LGB (fig. 1) présente un signal plus bruité que celui du LX-LGC (fig. 2). Les hautes fréquences (autour de 5700 Hz) correspondent au bruit de la turbine de l'avion. Le bruit de fond est globalement plus élevé en raison du bruit aérodynamique caractérisé par un spectre large bande.

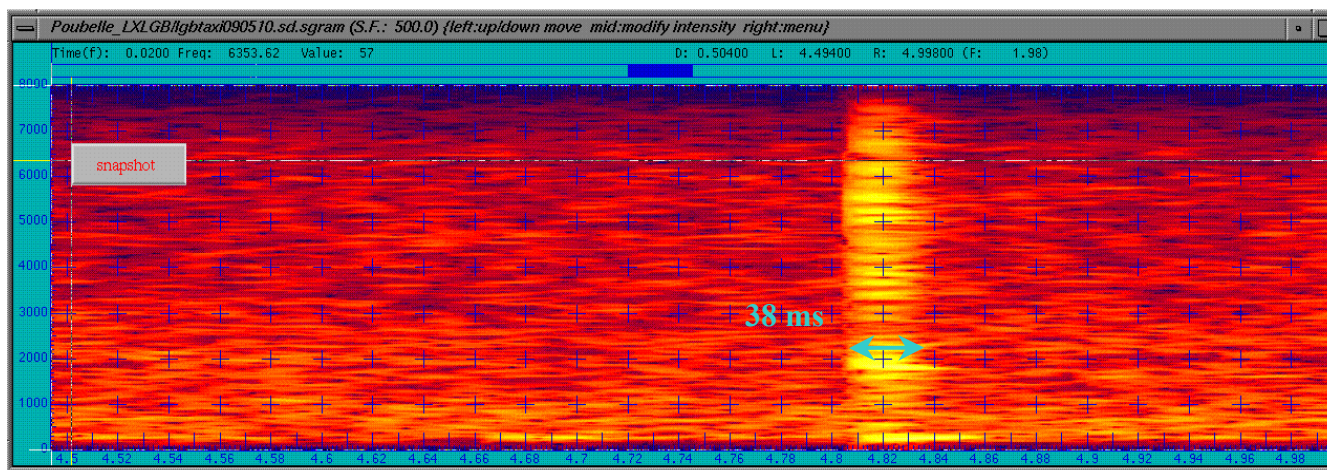
**Fig. 3:** *Représentation Temps – Fréquence du bruit transcrit. Time – Frequency representation of the transcribed noise.*

La figure ci-dessus représente le bruit enregistré sur le CVR de l'accident et transcrit comme l'activation des taxi lights. La figure suivante représente un enregistrement du bruit généré par l'activation des taxi lights lors des essais au sol.

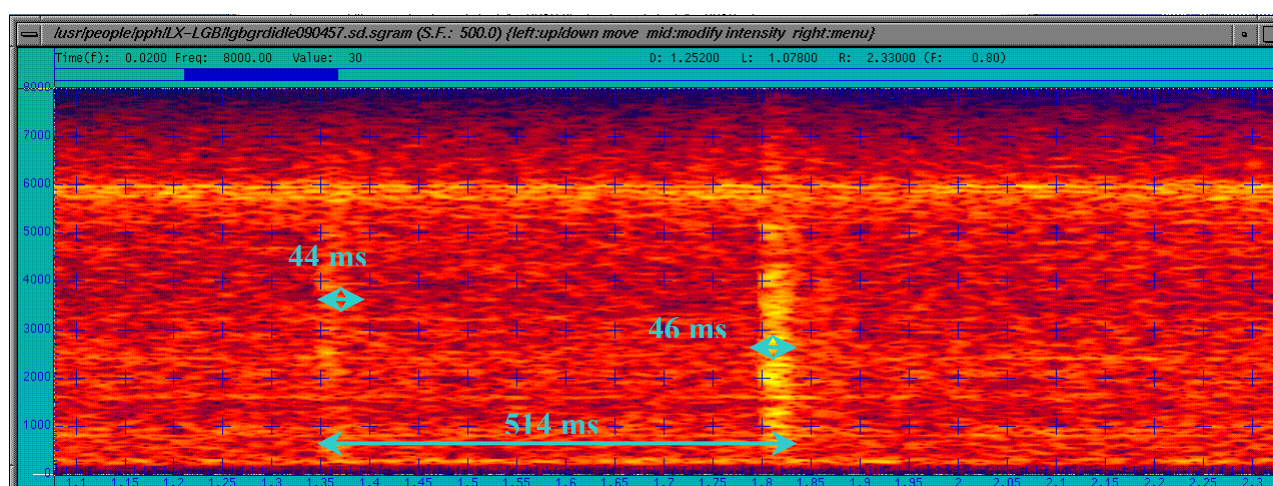
**09 h 04 min 58 s : "Bruit de sélecteur similaire au déplacement du Ground Idle Stop" / "Sound similar to the operation of the Ground Idle Stop Selector"**

**Fig. 6: Représentation Temps – Fréquence du bruit transcrit. Time – Frequency representation of the transcribed noise.**

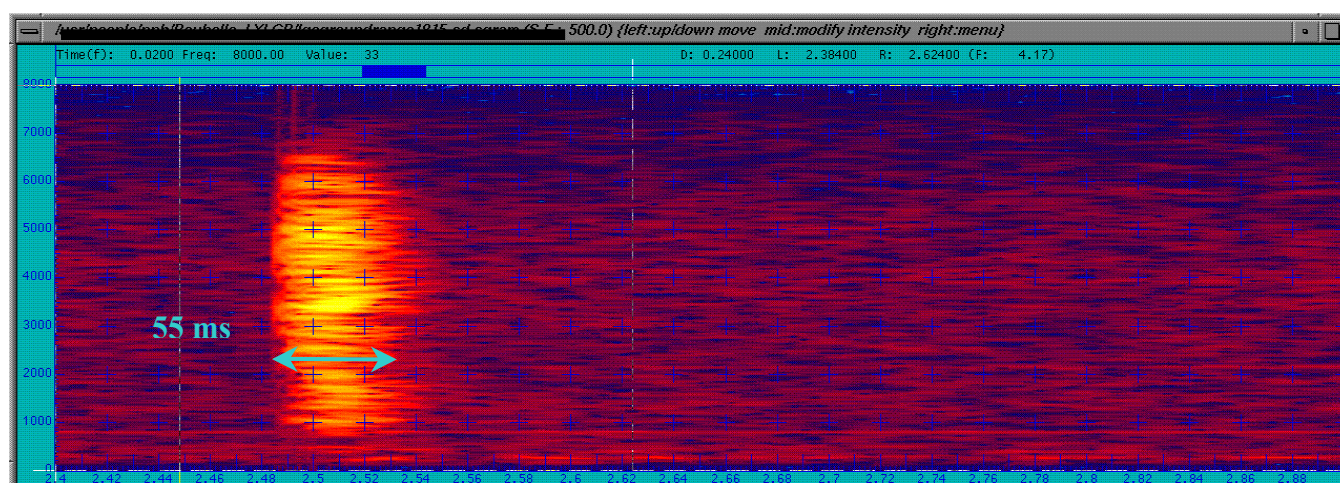
**Fig. 11: Représentation Temps-Fréquence du bruit généré. Time – Frequency representation of the generated noise.**

La figure ci-dessus représente le bruit du déplacement des *Ground Range Selector* dans le domaine temps - fréquence dans le cas où les deux leviers sont soulevés simultanément afin de retrouver une forme semblable à celle obtenue avec le bruit transcrit.

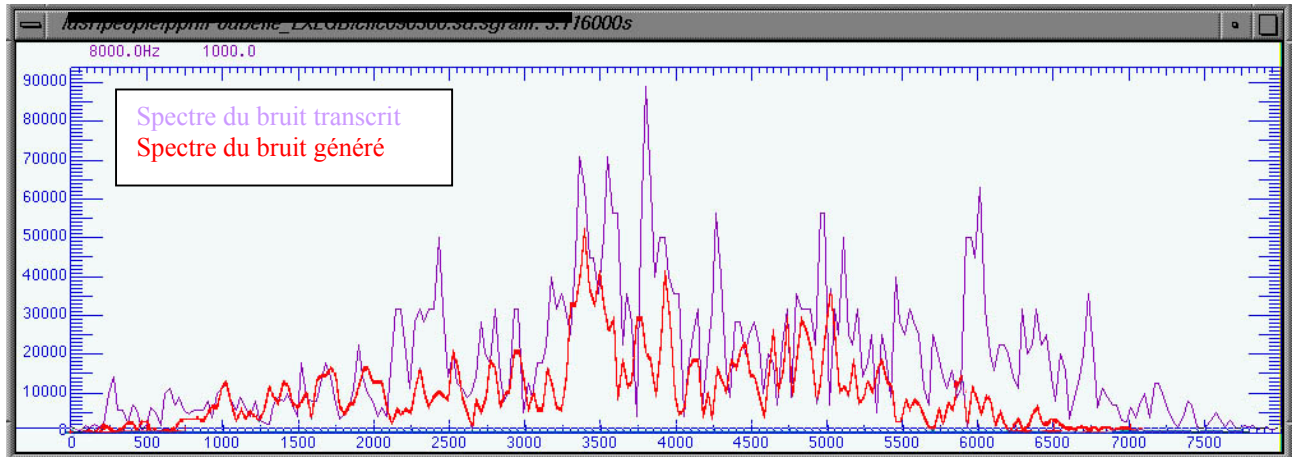
**Fig. 12: Comparaison des composantes fréquentielles des bruits transcrit (en mauve) et généré (en rouge). Spectrum comparison between the transcribed noise (in mauve) and the generated noise (in red)**

La figure ci-dessus est une superposition des représentations fréquentielles du bruit transcrit et du bruit généré. Les intensités du spectre du bruit transcrit apparaissent logiquement supérieures à celles du bruit généré (voir paragraphe 3.2 *Environnement sonore / Acoustic environment*). On constate ainsi que les deux spectres sont très proches. On rappelle que les pics entre 5500 et 6000 Hz proviennent du fonctionnement du turbopropulseur.

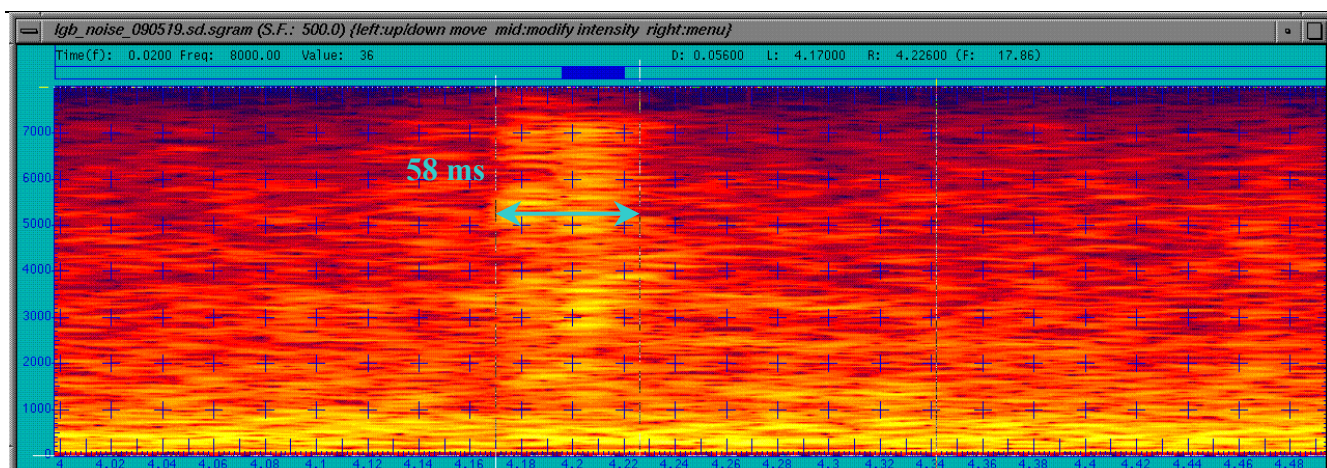
**09 h 05 min 19 s : "Bruit" / "Noise"**

**Fig. 16:** *Représentation Temps - Fréquence du bruit à identifier). Time Frequency representation of the noise to be identified.*

Ce bruit peut se décomposer temporellement en deux parties correspondant à deux « clics » distincts mais très rapprochés. Sa durée totale est de **58 ms**.

*This noise can be decomposed temporally in two parts corresponding with two separate but adjacent noises. Its total duration is **58 ms**.*

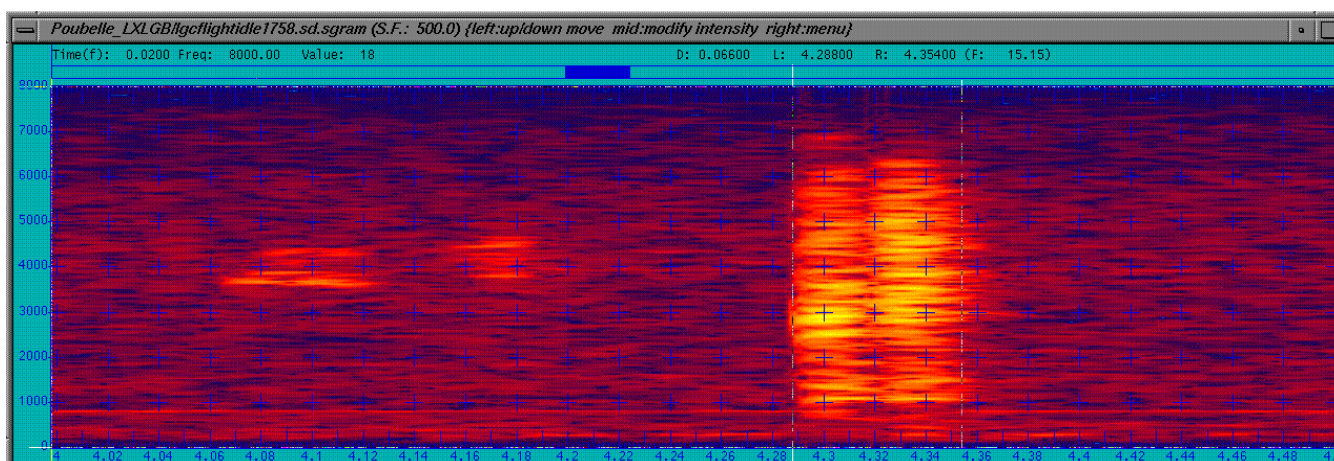
**Fig. 17:** *Représentation Temps - Fréquence du mouvement de la manette des gaz mise en position « Flight Idle ». Time Frequency representation of the operation of the throttle moved to « Flight Idle » position.*

*The above figure corresponds to the movement of the thrust levers on the Fokker 50 registered LX-LGC. The thrust levers were moved to the Flight Idle position from the Ground Idle position. The same two separate clicks can be seen. The total duration of this noise was **70 ms**.*

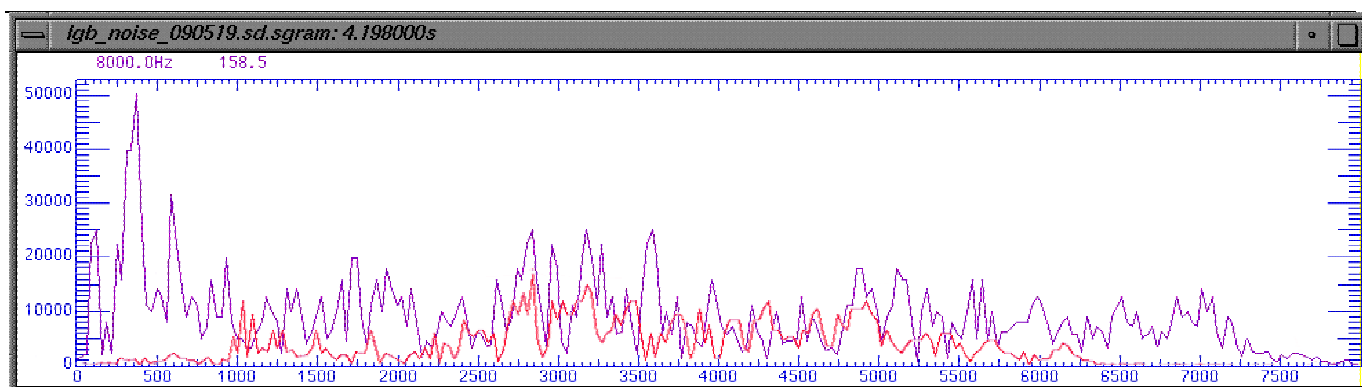
**Fig. 18:** Comparaison des composantes fréquentielles des bruits transcrit (en mauve) et généré (en rouge).  
**Spectrum comparison between the transcribed noise (in mauve) and the generated noise (in red)**

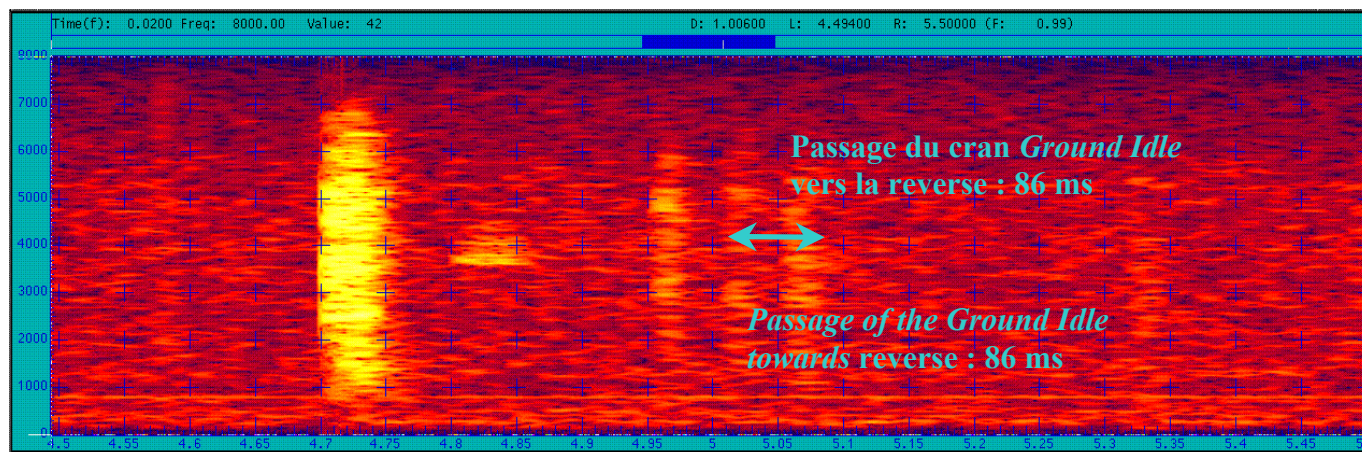
**Fig. 19:** Représentation Temps - Fréquence issue du mouvement de la manette des gaz mise en position « Reverse » depuis la position *Flight Idle*. **Time Frequency representation of the movement of the throttle from the Flight Idle position to the « Reverse » position.**

*Since this is a movement of a lever, the same double signature of the noise is obtained. In this case, this noise is longer than the one transcribed, the known causes being as described in section 3.4.2. The comparison of the spectra shows :*

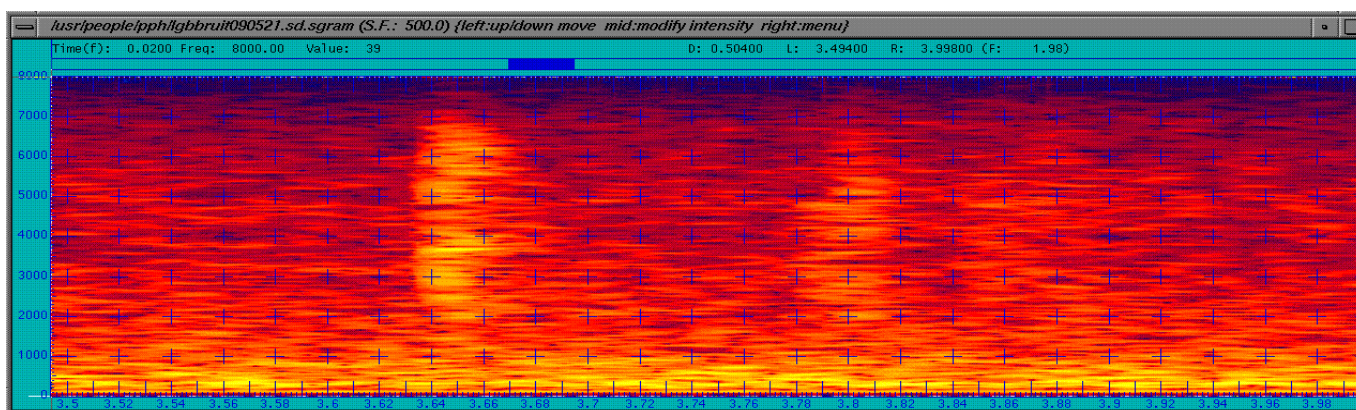
**09 h 05 min 21 s : "Bruit similaire à la manoeuvre de la commande des flaps" / "Sound similar to the operation of flaps control"**

**Fig. 22 : Représentation Temps – Fréquence du bruit. Time – Frequency representation of the noise.**

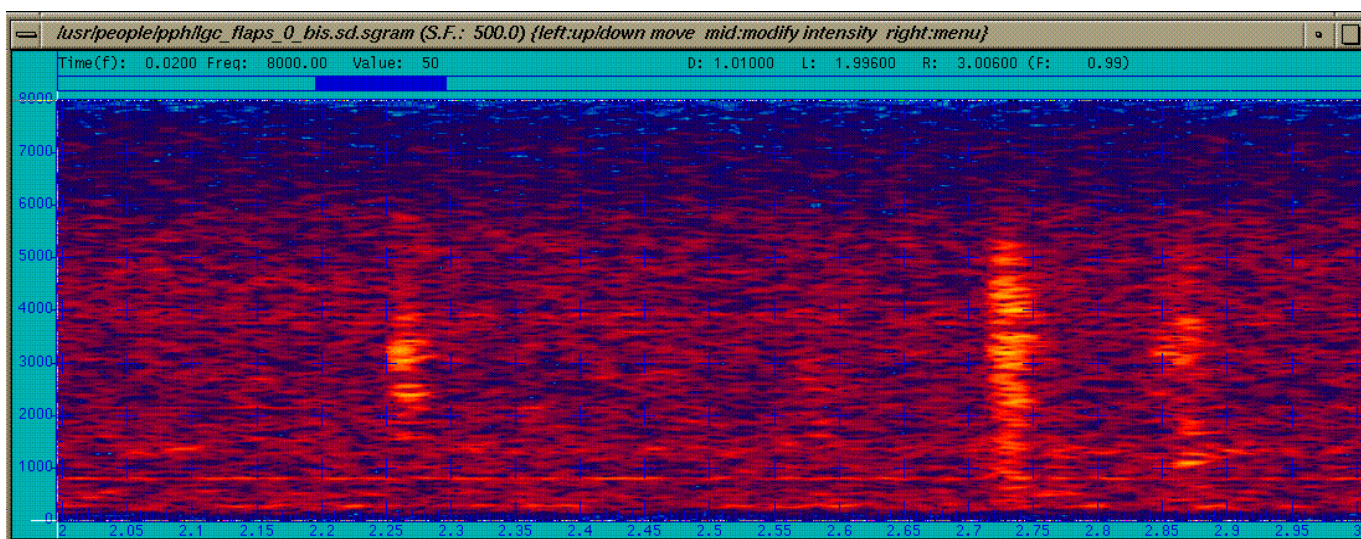
**Fig. 23 : Représentation Temps – Fréquence du bruit de la commande des volets ramenée en position 0°. Time – Frequency representation of the flaps command noise moved to 0°.**
