## **LISTE DES ANNEXES**

**ANNEXE 5** : Service Bulletin ABSC N° Fo50-32-4, révision 1

Subject: **Accident of LUXAIR LGL9642, Fokker 50, 6th November 2002**

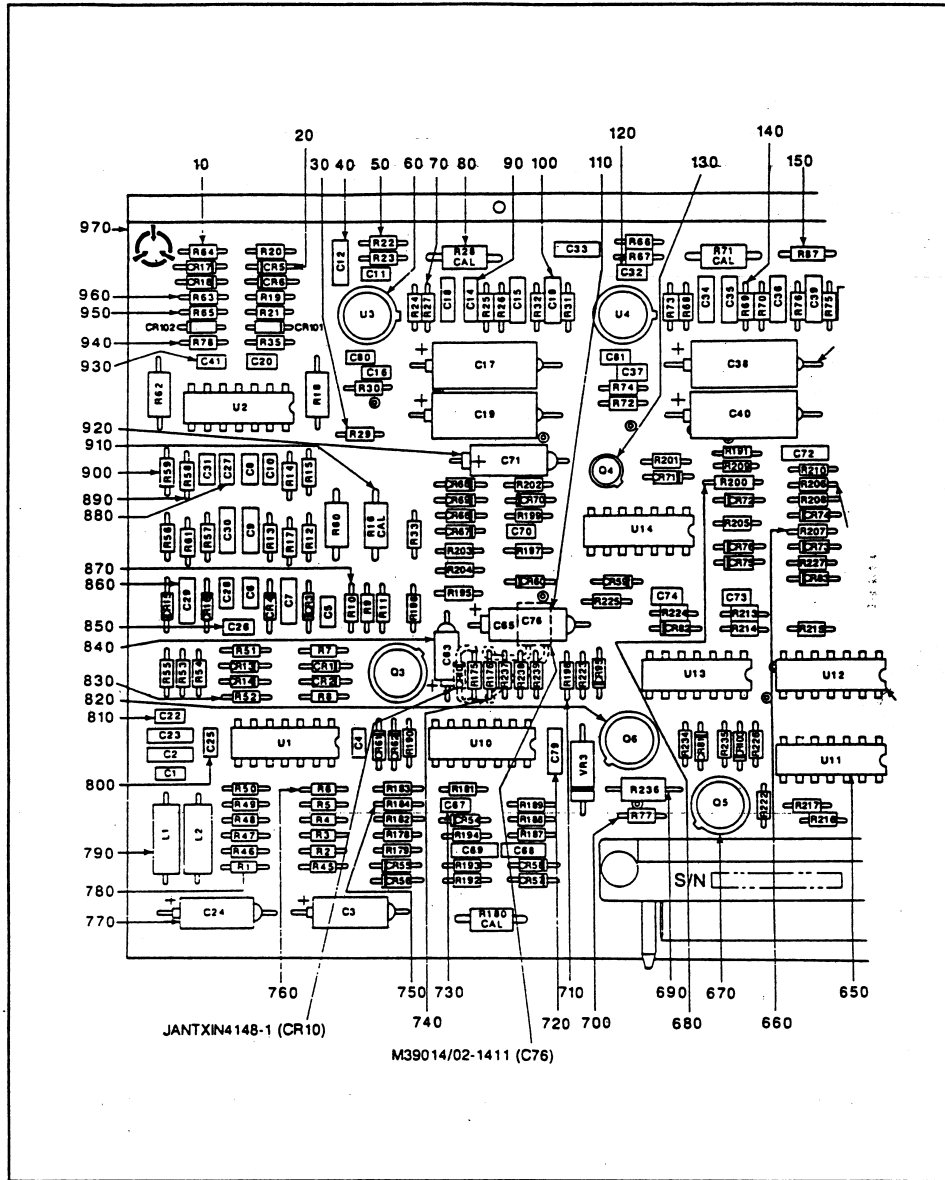
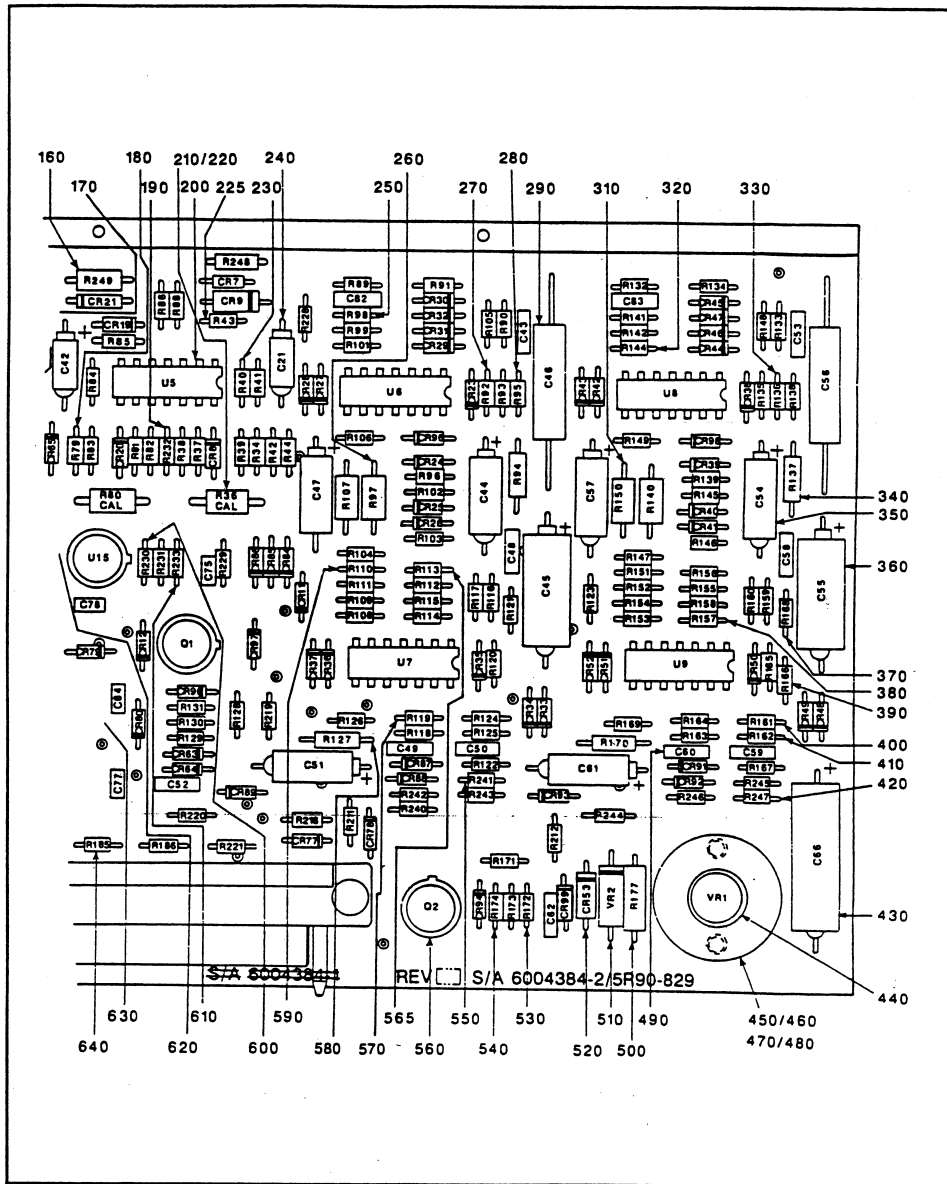
Modification of Wheel Control Board to 6004384-2/5R90-829  
Figure 1 (Sheet 1 of 2)

- A. **EFFECTIVITY:** This Service Bulletin is applicable to all Control Unit Assemblies 6004125 used on F27 Mk050 (FOKKER 50) aircraft.
- B. **REASON:** This Service Bulletin is issued to inform operators of the new Control Unit 6004125-1 and provides instructions to modify the 6004125 control unit assembly into the 6004125-1 assembly. The new unit differs from the old only in the addition of one capacitor and one diode, one each per wheel board. These components prevent a condition during power up of the skid control box whereby a signal pulse is inadvertently sent to the ground control relay thus affecting the flight idle stop solenoids.

- (1) Rework Control Board Subassembly 6004125 into 6004125-1 as follows (See Figure 1):
  - (a) Install Capacitor M39014/02-1411 (C76) and Diode JANTXIN4148-1 (CR10) on the non-component side of board as shown in Figure 1.

- 1 Solder each component to board and trim ends.
- 2 When installing a new component, maintain 0.03 inch (0,76 mm) minimum space between the component and the surface of the board.

- 4 Apply a protective coating of Hysol PC-29M or Humiseal 1B31 over each component and the repaired area of the board. Apply only a very thin coat, 0.002 inch (0,051 mm) maximum and do not allow a buildup of coating between the other parts of the board.

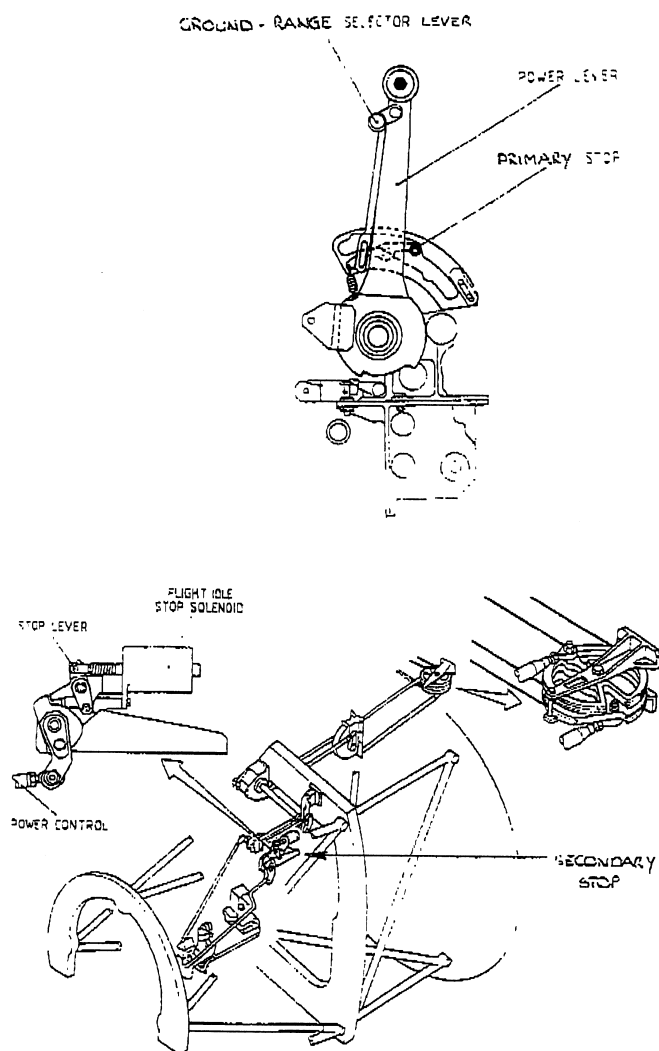
The Automatic Flight Idle Stop  
Figure 1

It has been reported that handling of the ground-range selector-levers occurs during flight, e.g. when the hand of the pilot holds the selector levers during turbulent weather conditions. This may result in the situation that the power levers pass the primary stop and now rest against the secondary stop. When the engine controls are incorrectly adjusted this may result in a propeller RPM/drag increase. When the power levers remain against the secondary stop during aircraft landing, it may not be possible to move the power levers into the Ground range due to the imposed friction.

The secondary or so called automatic flight-idle stop prevents inadvertent entering of the propeller into the Ground range during flight if the ground-range selector-levers are accidentally operated. The location of this secondary stop on the engine also ensures protection after a control cable failure.

2. During an operational check of the anti-skid system. The AOM recommends to perform this check before the landing when a lightning strike is experienced while the landing gear is down. Besides activation of the automatic flight-idle stop, also the rating on the ERP may change automatically to Go Around when the "Cruise rating in approach" modification is incorporated (refer to SBF50-73-010) into the aircraft. Fokker considers to include a note in the AOM which informs flight crews about this possible rating change.

AFM procedures recommend operation of the selector levers only after nose wheel touch-down. For this issue it is considered the operators responsibility to take action where considered appropriate.

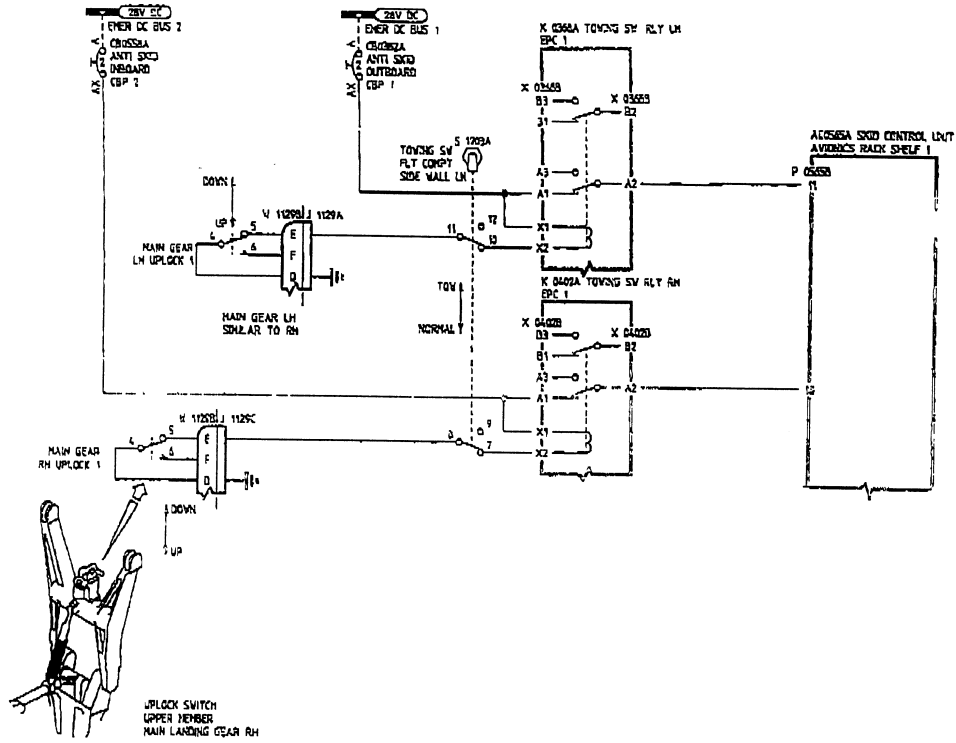
The Anti-Skid Control System  
Figure 2

- (1) Cases have been experienced of intermittent or no braking action from the normal braking system.  
Investigation has learned that this is caused by EMI disturbance signals. The EMI signals cause undesired signals in the wiring from the wheel speed sensors to the anti skid control box, which in turn could cause undesired dump-signals from the anti-skid control box. As a result of this hydraulic brake pressure will be dumped resulting in intermittent or no braking action.
