LIST OF ANNEXES

ANNEX 5: Service Bulletin ABSC N° Fo50-32-4, revision 1

Subject: **Accident of LUXAIR LGL9642, Fokker 50, 6th November 2002**

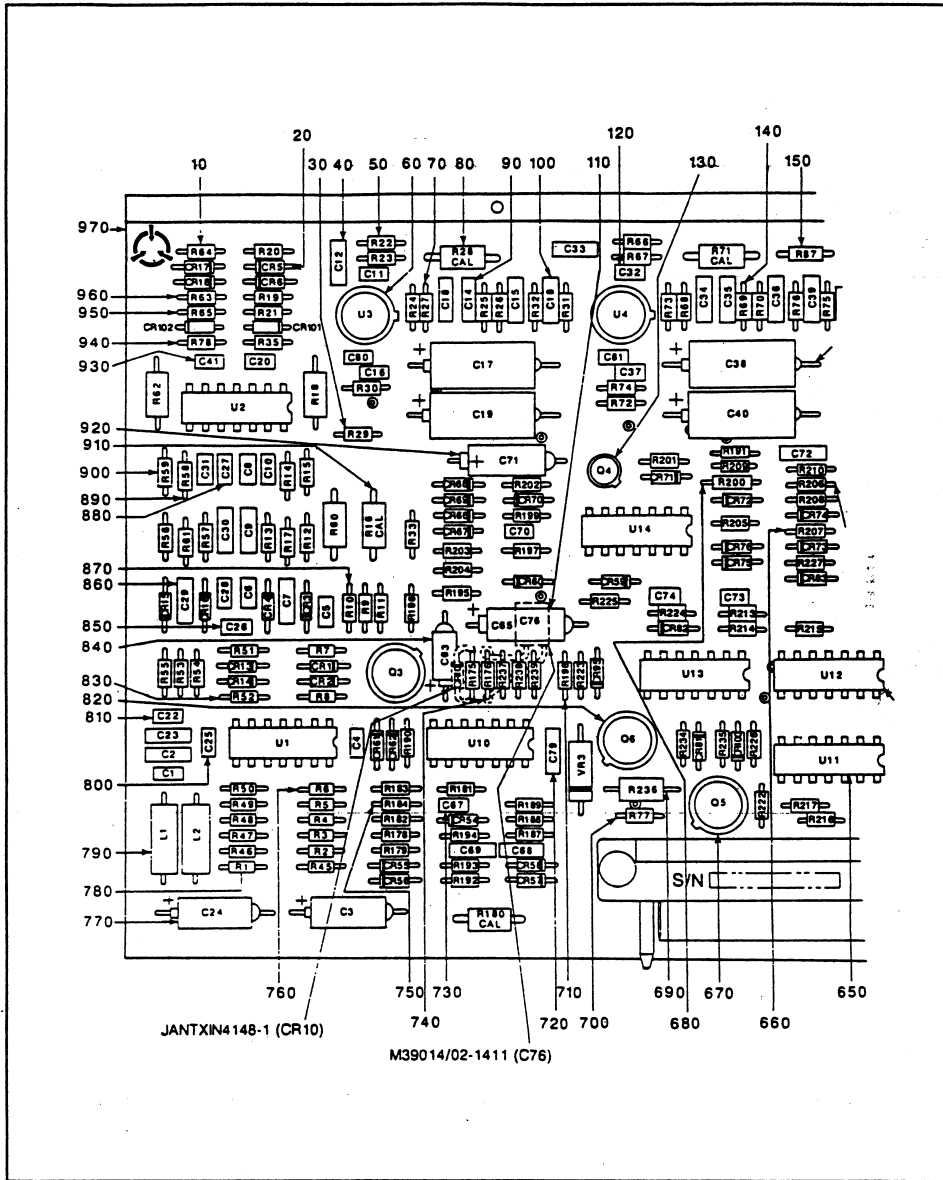
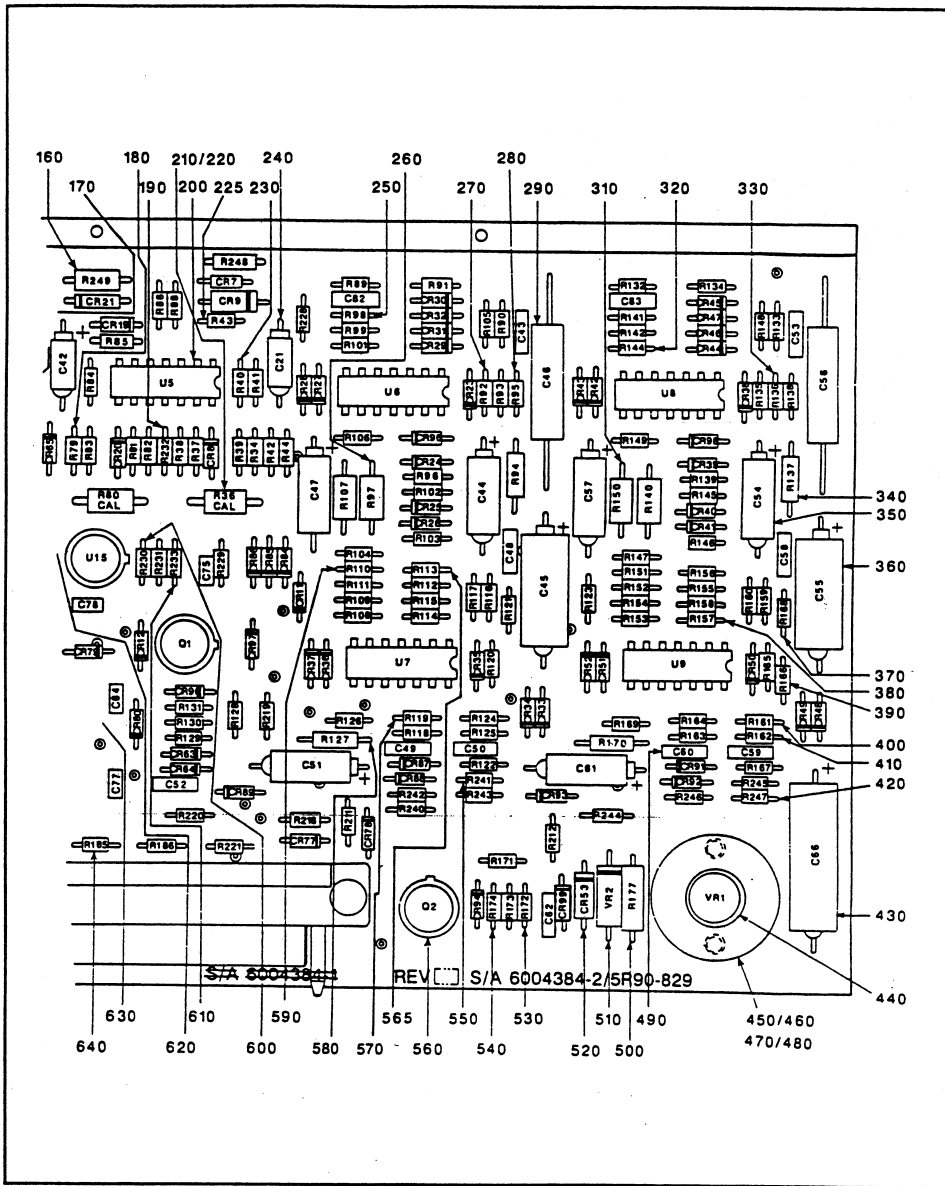
Modification of Wheel Control Board to 6004384-2/5R90-829
Figure 1 (Sheet 1 of 2)

- A. **EFFECTIVITY:** This Service Bulletin is applicable to all Control Unit Assemblies 6004125 used on F27 Mk050 (FOKKER 50) aircraft.
- B. **REASON:** This Service Bulletin is issued to inform operators of the new Control Unit 6004125-1 and provides instructions to modify the 6004125 control unit assembly into the 6004125-1 assembly. The new unit differs from the old only in the addition of one capacitor and one diode, one each per wheel board. These components prevent a condition during power up of the skid control box whereby a signal pulse is inadvertently sent to the ground control relay thus affecting the flight idle stop solenoids.

- (1) Addition of one capacitor (C76) and one diode (CR10) on each wheel control board.
 - (2) Reidentifying reworked boards and control unit and performing testing at unit bench and aircraft levels.

- (1) Rework Control Board Subassembly 6004125 into 6004125-1 as follows (See Figure 1):
 - (a) Install Capacitor M39014/02-1411 (C76) and Diode JANTXIN4148-1 (CR10) on the non-component side of board as shown in Figure 1.

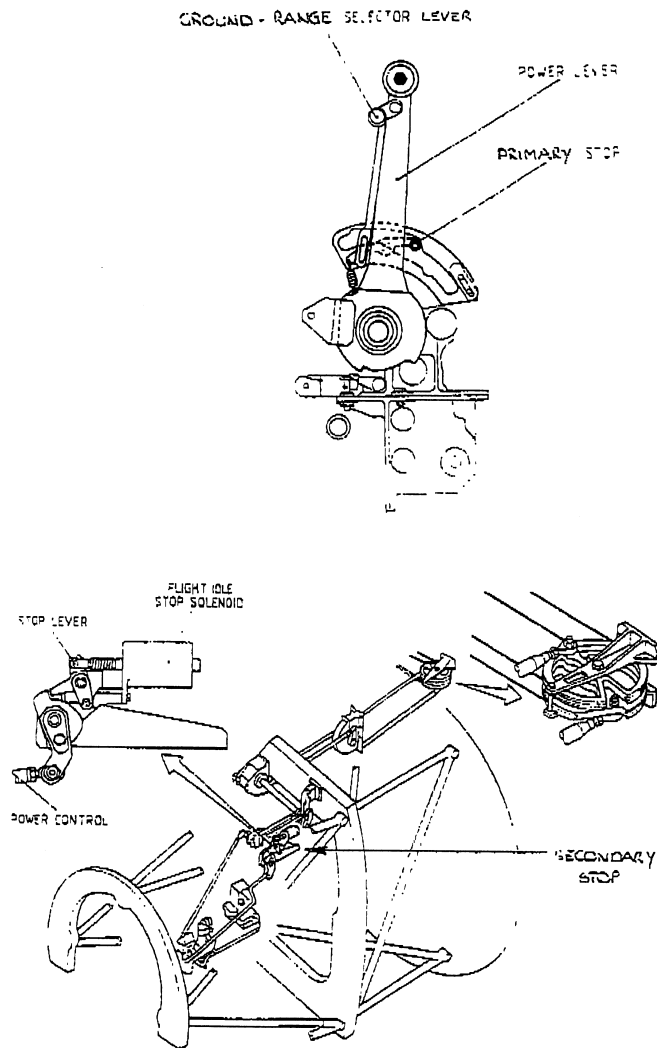
The Automatic Flight Idle Stop
Figure 1

The secondary or so called automatic flight-idle stop prevents inadvertent entering of the propeller into the Ground range during flight if the ground-range selector-levers are accidentally operated. The location of this secondary stop on the engine also ensures protection after a control cable failure.

2. During an operational check of the anti-skid system. The AOM recommends to perform this check before the landing when a lightning strike is experienced while the landing gear is down. Besides activation of the automatic flight-idle stop, also the rating on the ERP may change automatically to Go Around when the "Cruise rating in approach" modification is incorporated (refer to SBF50-73-010) into the aircraft. Fokker considers to include a note in the AOM which informs flight crews about this possible rating change.

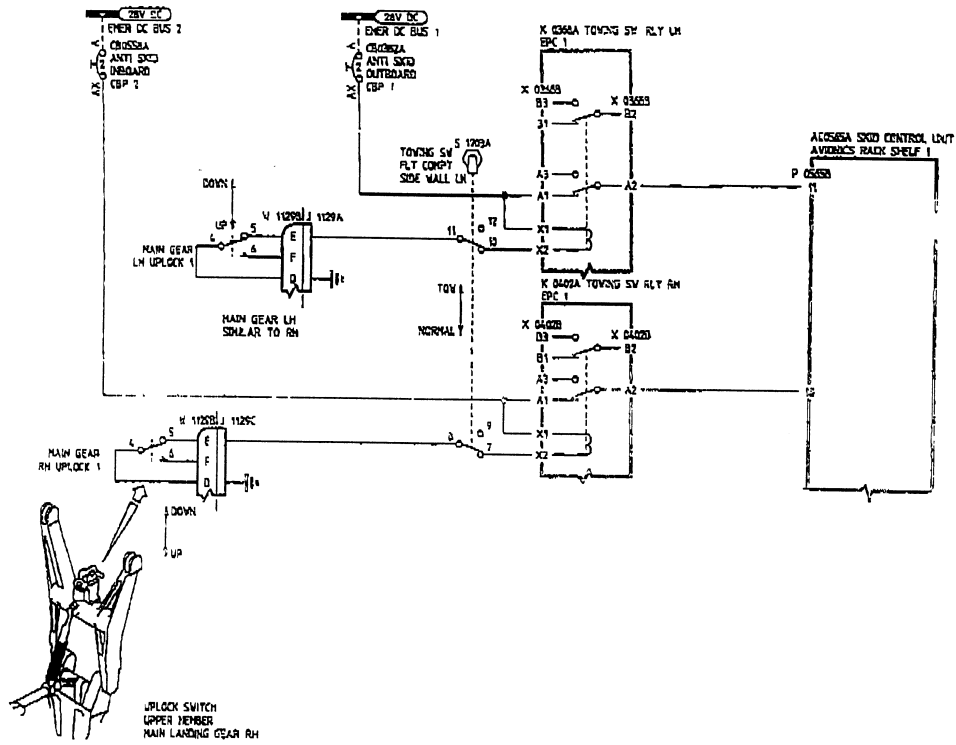
The Anti-Skid Control System
Figure 2

- (1) Cases have been experienced of intermittent or no braking action from the normal braking system.
Investigation has learned that this is caused by EMI disturbance signals. The EMI signals cause undesired signals in the wiring from the wheel speed sensors to the anti skid control box, which in turn could cause undesired dump-signals from the anti-skid control box. As a result of this hydraulic brake pressure will be dumped resulting in intermittent or no braking action.
