INVESTIGATION COMMISSION
ON THE ACCIDENT WHICH OCCURED 6 NOVEMBRE 2002
AT LUXEMBOURG
TO THE FOKKER 27 MK050 REGISTERED LX – LGB
OPERATED BY LUXAIR

PRELIMINARY REPORT

January 2003

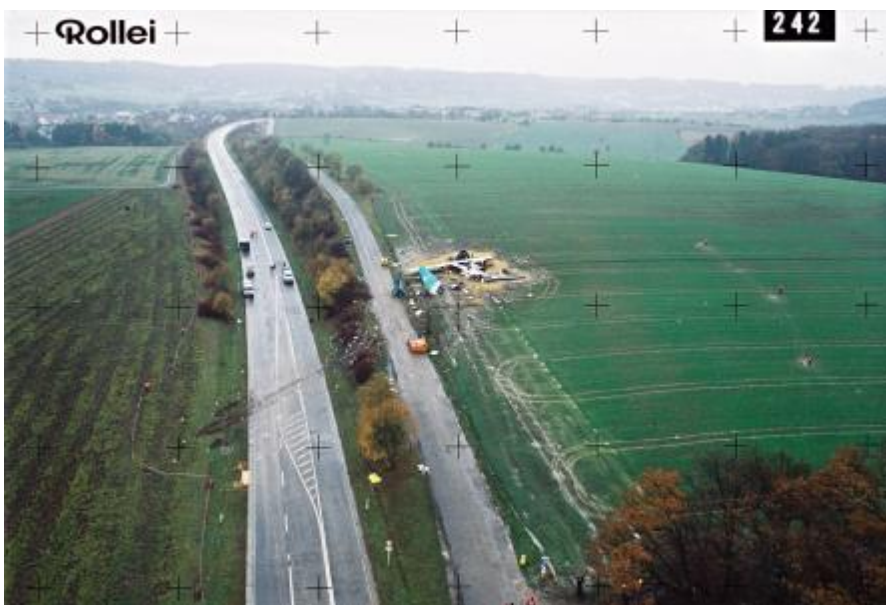
Scraping marks on the road, notably from the left wing tip show that the aircraft scratched across the road before hitting an embankment at the north side of the road RN1.

Aerial view of RN1 and the site

The major part of the damage results from this blow during which the aircraft lost three blades from the right propeller and two from the left propeller, wheels from the left and right landing gear.

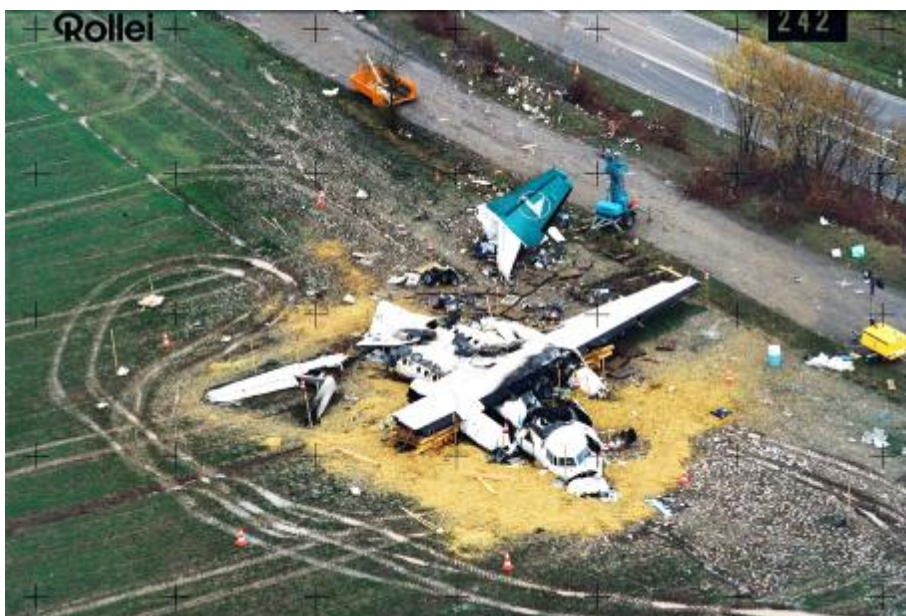
After this bounce, the empennage and part of the right outboard wing broke away, the aft portion of the fuselage turned around and the aircraft came to rest 25 meters further away in a ploughed field.

Aerial view of the right hand side of the aircraft

The fuselage and the wings remained attached. The aft portion including the rudder and the horizontal stabiliser was detached. On the fuselage a more important deformation is noted on the right hand side as compared to the left side. The central part of the fuselage was burnt.

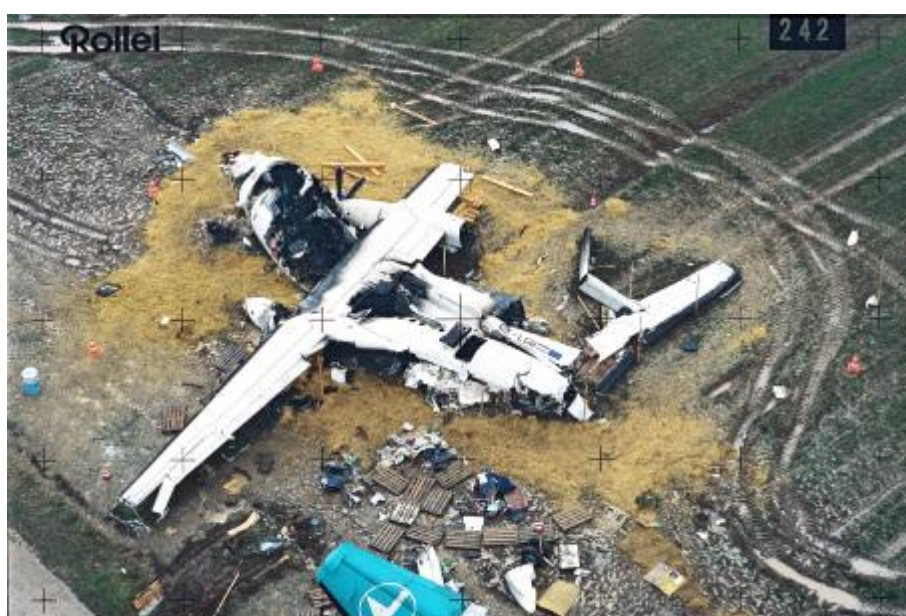
Aerial view of the left hand side of the aircraft

The engines suffered light damage, except the lower parts that were in contact with the ground. On the left hand side, all propeller blades are broken at their root. On the right hand side, three propeller blades out of six remain attached to the hub. All blades, of composite construction, are damaged. Some are delaminated and others are totally destroyed. Blade pitch angle of the LH propeller is close to feather. Blade pitch of the RH propeller is in the beta range.
