**LISTE DES ANNEXES**

**Accident  
survenu le 6 novembre 2002  
en approche de l'aéroport  
de Luxembourg  
au Fokker 50  
immatriculé LX-LGB  
exploité par Luxair**

*Accident  
occurred on November 6, 2002,  
on approach to  
Luxembourg Airport  
to the Fokker 50  
registered LX-LGB  
operated by Luxair*

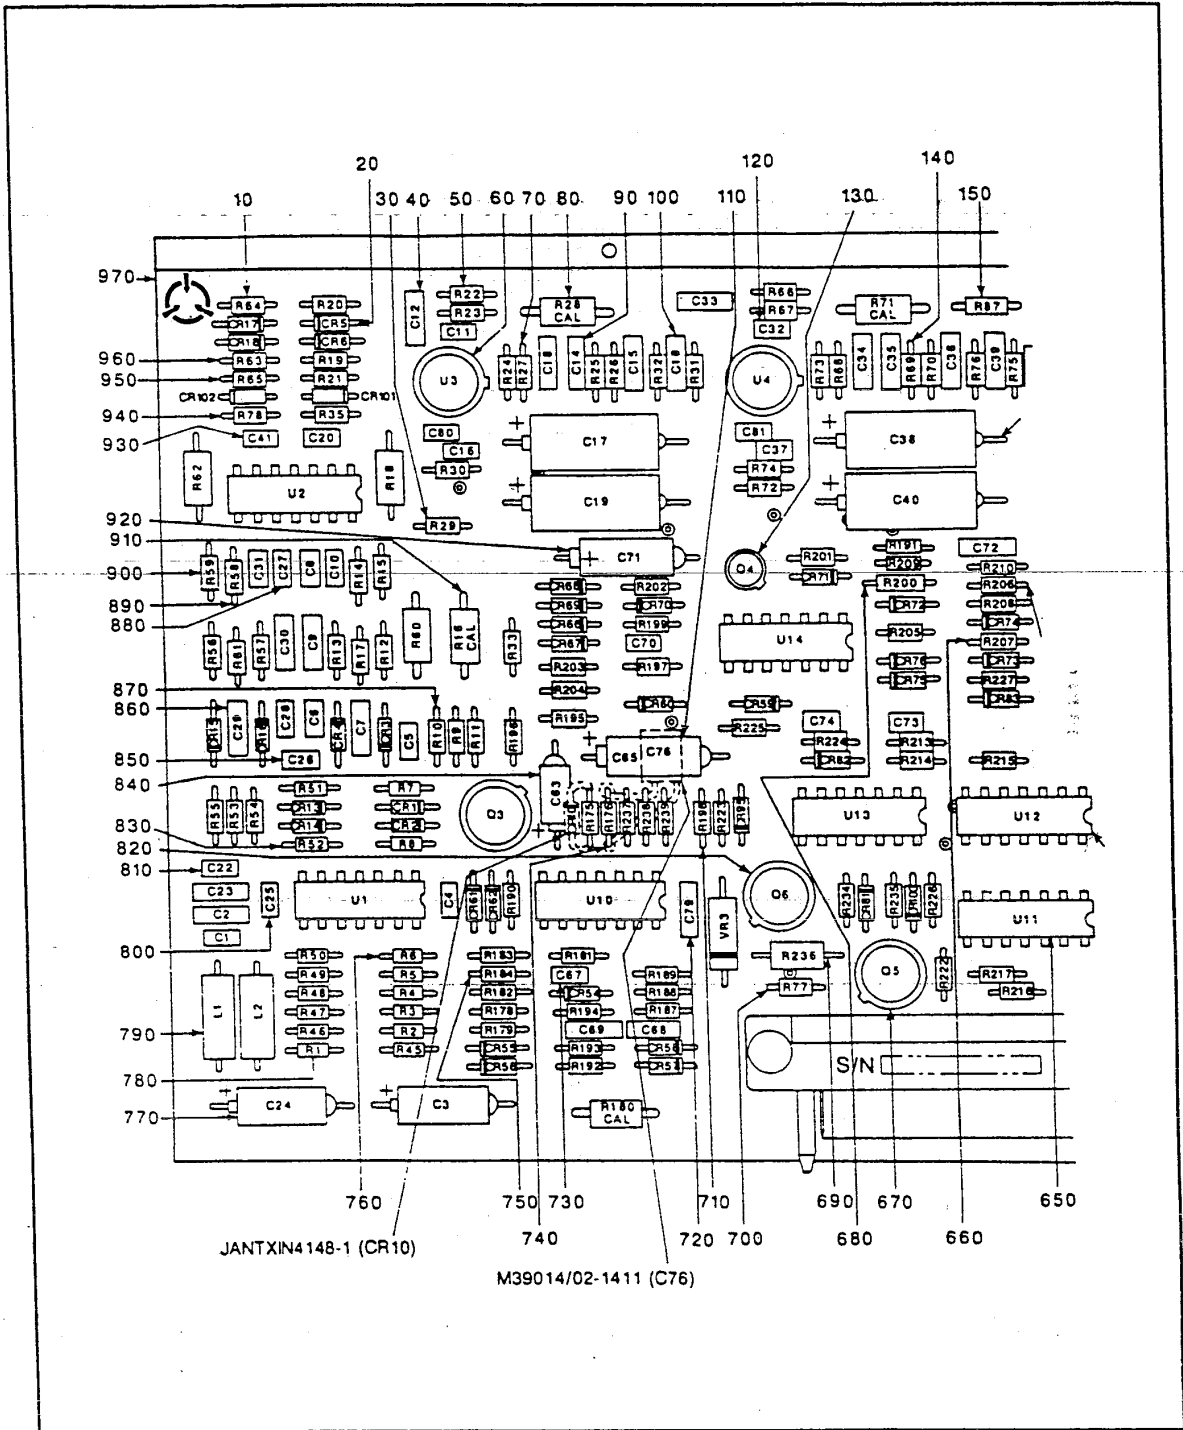
Modification of Wheel Control Board to 6004384-2/5R90-829  
Figure 1 (Sheet 1 of 2)

- (1) Rework Control Board Subassembly 6004125 into 6004125-1 as follows (See Figure 1):
  - (a) Install Capacitor M39014/02-1411 (C76) and Diode JANTXIN4148-1 (CR10) on the non-component side of board as shown in Figure 1.

- 4 Apply a protective coating of Hysol PC-29M or Humiseal 1B31 over each component and the repaired area of the board. Apply only a very thin coat, 0.002 inch (0,051 mm) maximum and do not allow a buildup of coating between the other parts of the board.

- (1) Board identification is located adjacent to the board connector as shown in Figure 1.
- (2) On each control board, cross out but do not obliterate existing identification.
- (3) Reidentify board as part number S/A 6004384-2/5R90-829 in 0.10 inch (2,54 mm) high characters, using a contrasting color epoxy marking ink, Hysol Wornowink, Series M.

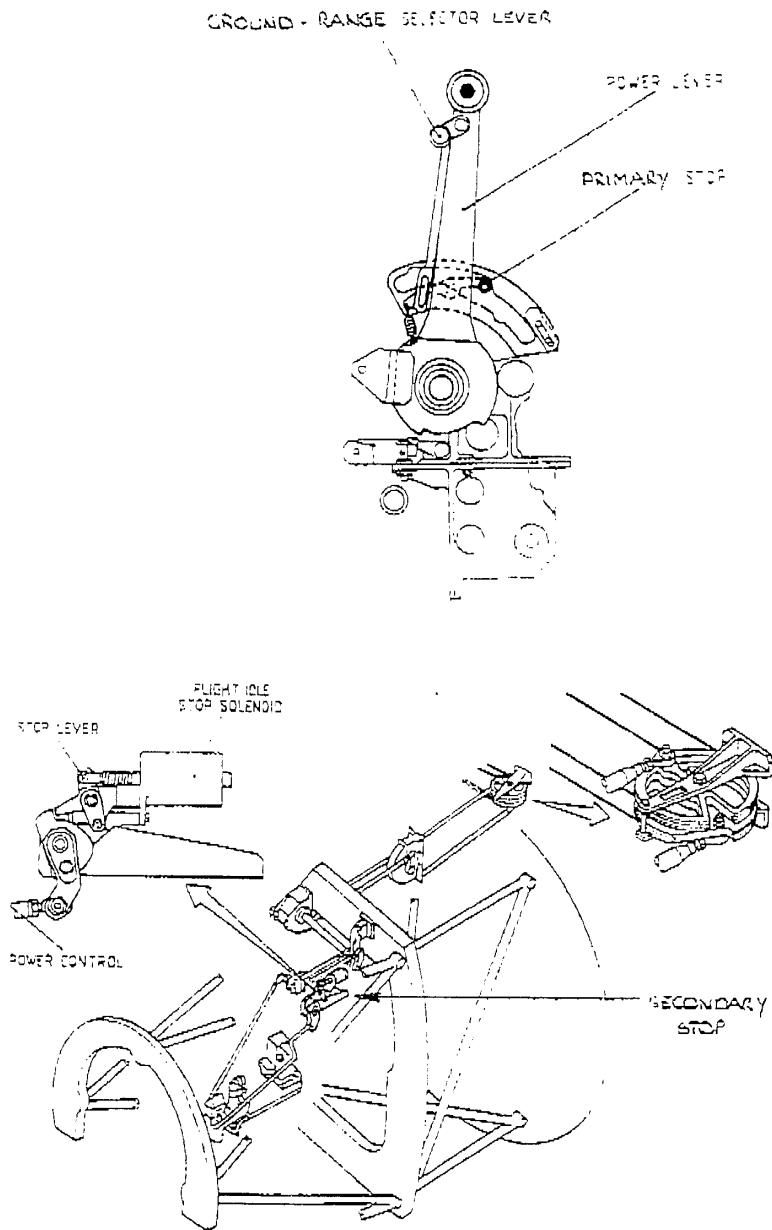
The Automatic Flight Idle Stop  
Figure 1

Primary stop (Refer to figure 1)

It has been reported that handling of the ground-range selector-levers occurs during flight, e.g. when the hand of the pilot holds the selector levers during turbulent weather conditions. This may result in the situation that the power levers pass the primary stop and now rest against the secondary stop. When the engine controls are incorrectly adjusted this may result in a propeller RPM/drag increase. When the power levers remain against the secondary stop during aircraft landing, it may not be possible to move the power levers into the Ground range due to the imposed friction.

AFM procedures recommend operation of the selector levers only after nose wheel touch-down. For this issue it is considered the operators responsibility to take action where considered appropriate.

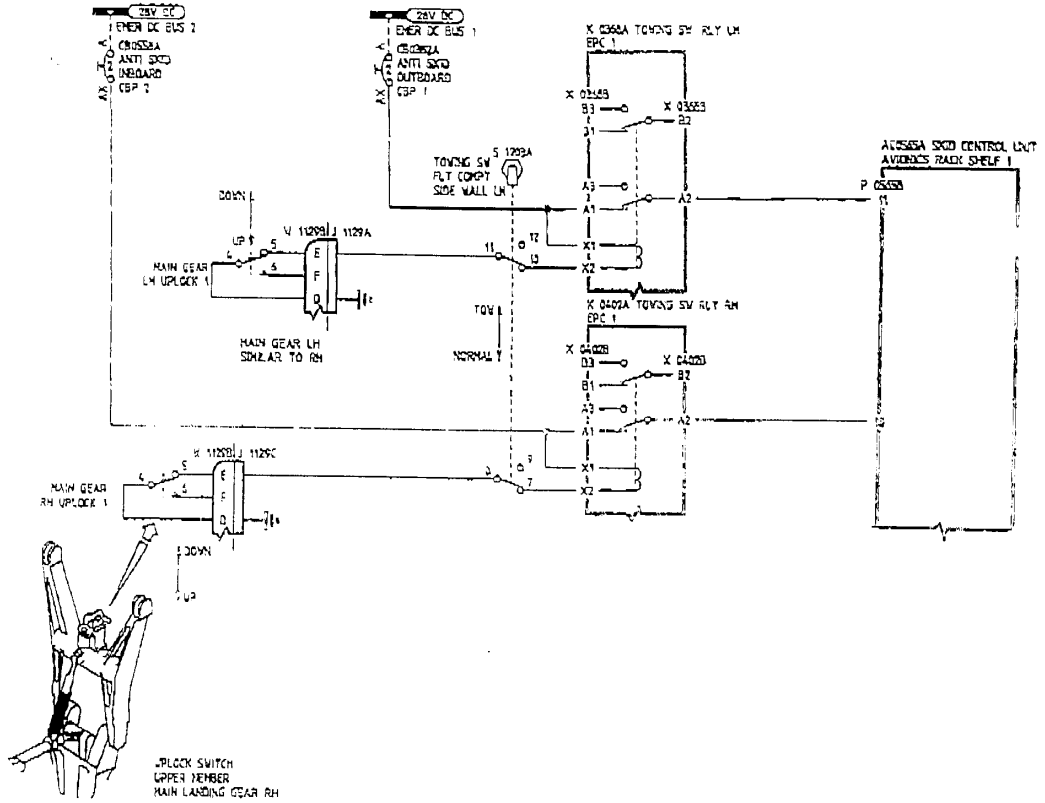
The Anti-Skid Control System  
Figure 2

Secondary stop (Refer to figure 1 and 2)
