**Accident  
survenu le 6 novembre 2002  
en approche de l'aéroport  
de Luxembourg  
au Fokker 50  
immatriculé LX-LGB  
exploité par Luxair**

*Accident  
occurred on November 6, 2002,  
on approach to  
Luxembourg Airport  
to the Fokker 50  
registered LX-LGB  
operated by Luxair*

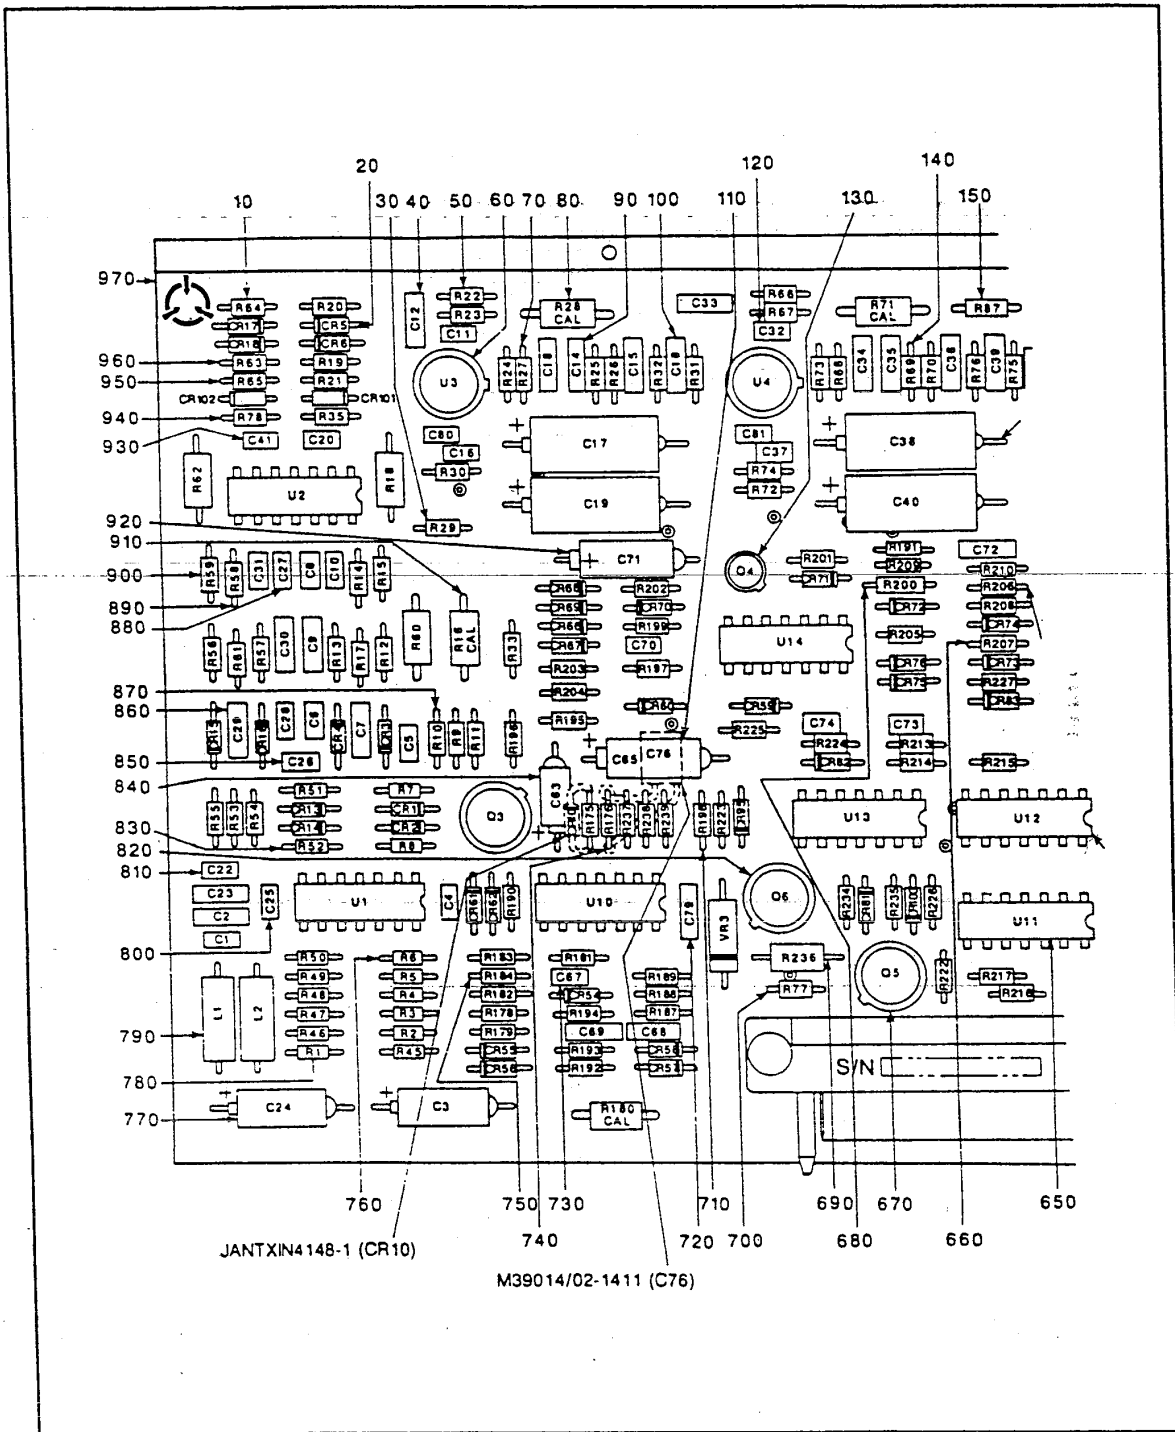
Modification of Wheel Control Board to 6004384-2/5R90-829  
Figure 1 (Sheet 1 of 2)

- A. **EFFECTIVITY:** This Service Bulletin is applicable to all Control Unit Assemblies 6004125 used on F27 Mk050 (FOKKER 50) aircraft.
- B. **REASON:** This Service Bulletin is issued to inform operators of the new Control Unit 6004125-1 and provides instructions to modify the 6004125 control unit assembly into the 6004125-1 assembly. The new unit differs from the old only in the addition of one capacitor and one diode, one each per wheel board. These components prevent a condition during power up of the skid control box whereby a signal pulse is inadvertently sent to the ground control relay thus affecting the flight idle stop solenoids.

- (1) Rework Control Board Subassembly 6004125 into 6004125-1 as follows (See Figure 1):
  - (a) Install Capacitor M39014/02-1411 (C76) and Diode JANTXIN4148-1 (CR10) on the non-component side of board as shown in Figure 1.

- (1) Board identification is located adjacent to the board connector as shown in Figure 1.
- (2) On each control board, cross out but do not obliterate existing identification.
- (3) Reidentify board as part number S/A 6004384-2/5R90-829 in 0.10 inch (2,54 mm) high characters, using a contrasting color epoxy marking ink, Hysol Wornowink, Series M.

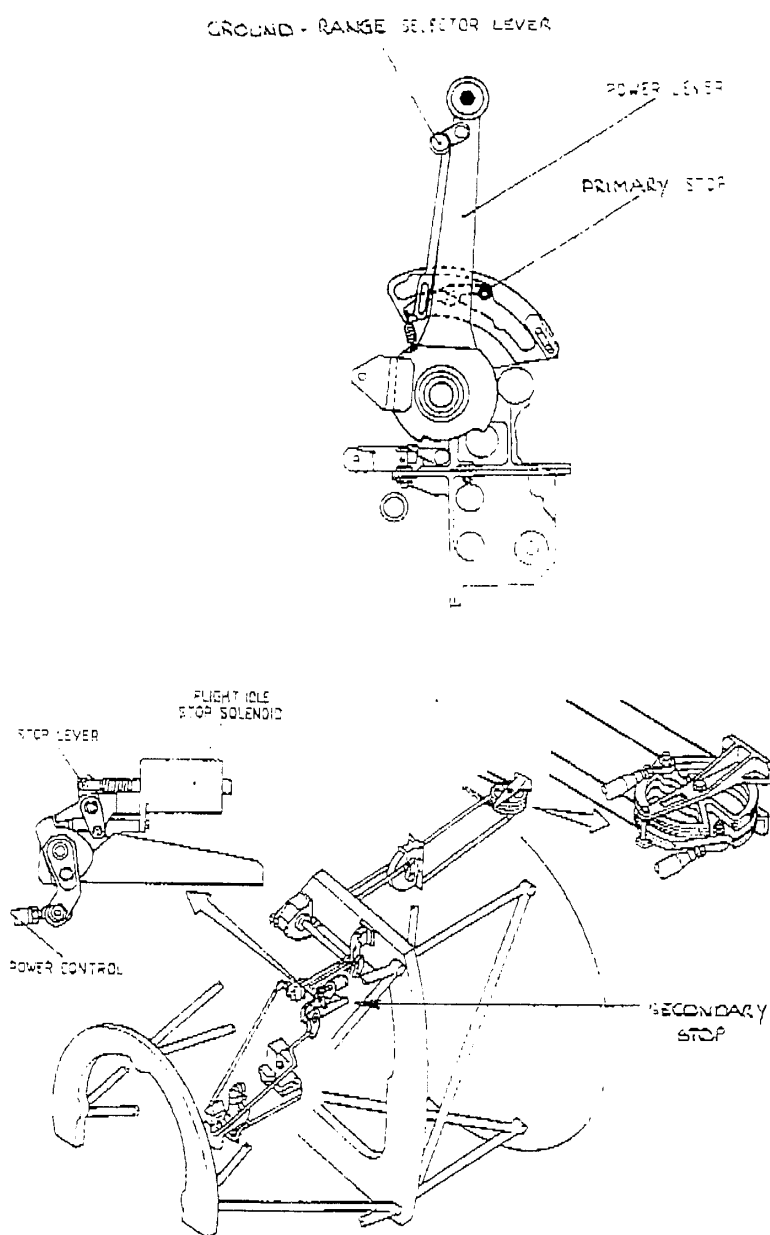
The Automatic Flight Idle Stop  
Figure 1

Primary stop (Refer to figure 1)

AFM procedures recommend operation of the selector levers only after nose wheel touch-down. For this issue it is considered the operators responsibility to take action where considered appropriate.
