INVESTIGATION COMMISSION
ON THE ACCIDENT WHICH OCCURED 6 NOVEMBRE 2002
AT LUXEMBOURG
TO THE FOKKER 27 MK050 REGISTERED LX – LGB
OPERATED BY LUXAIR

PRELIMINARY REPORT

January 2003

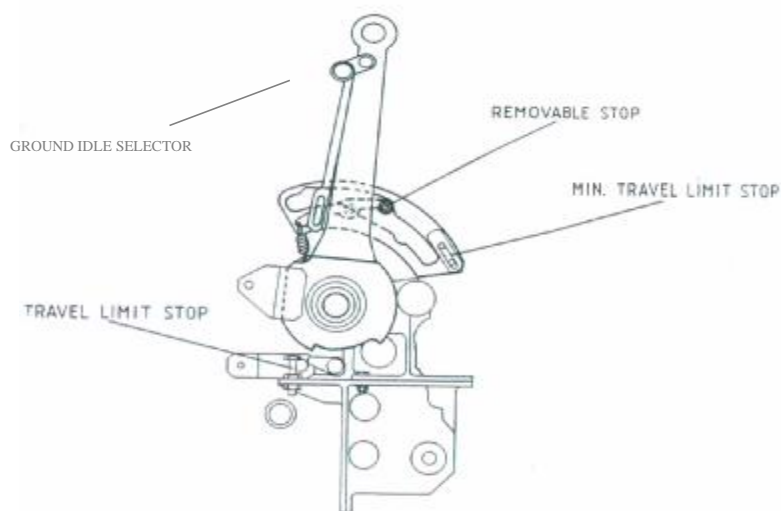
- a primary mechanical security (ground idle selector) on the power levers

Power levers and ground idle selector

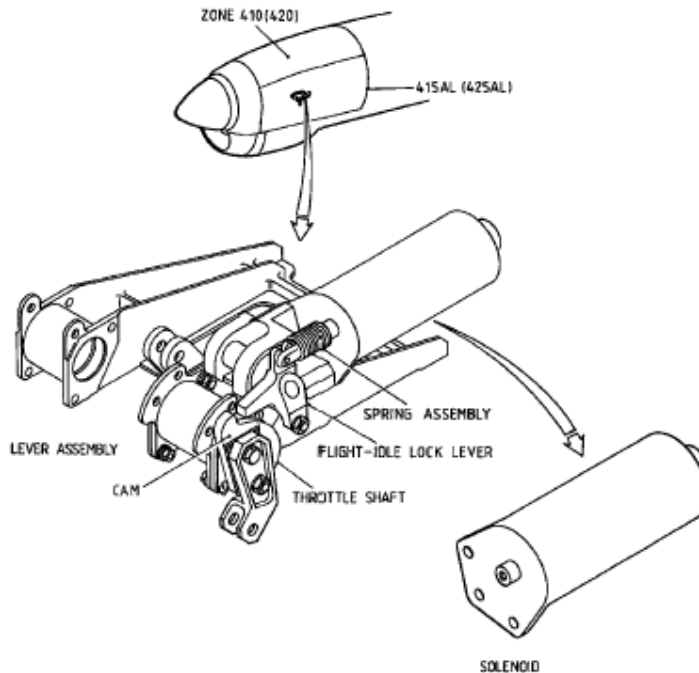
- a secondary electrical security (flight idle stop solenoid) on each engine.

To select the beta mode after landing, with the power levers in the flight idle position one has to grab and lift the ground idle selectors fixed to power levers and move the levers backward. This first mechanical stop on the power levers is doubled by a flight idle stop fixed to each engine and activated by solenoids designed to deny access in flight to the pitch range inferior to the in flight pitch range.
